Case Study 089:

HELIFIX REPAIRS: FERNDALE COURT

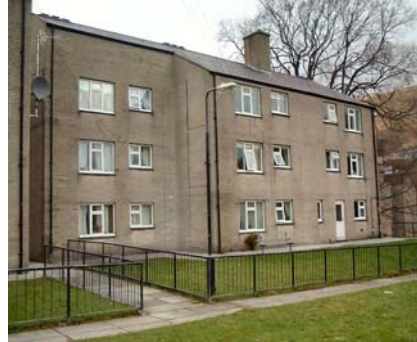
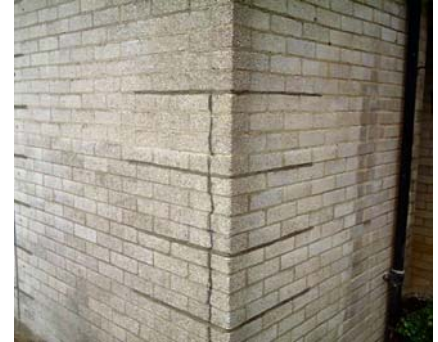
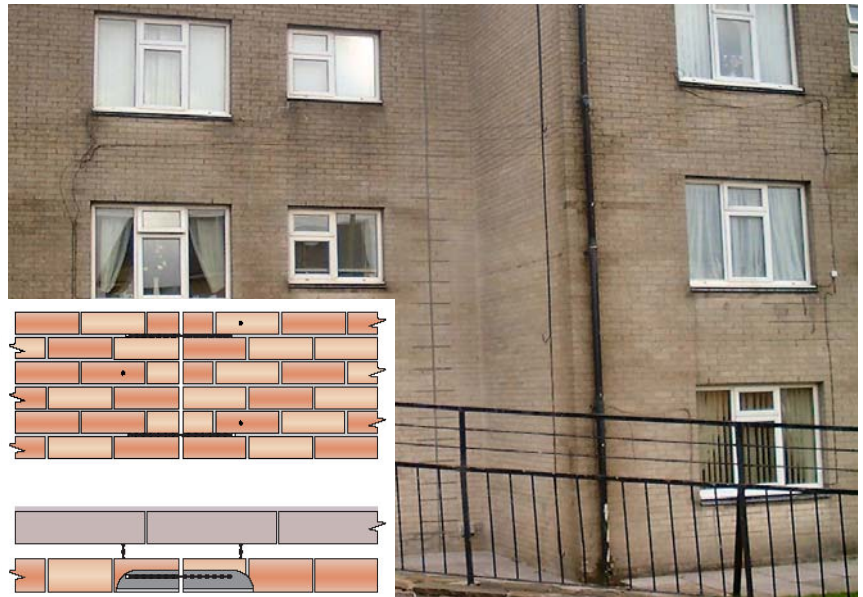
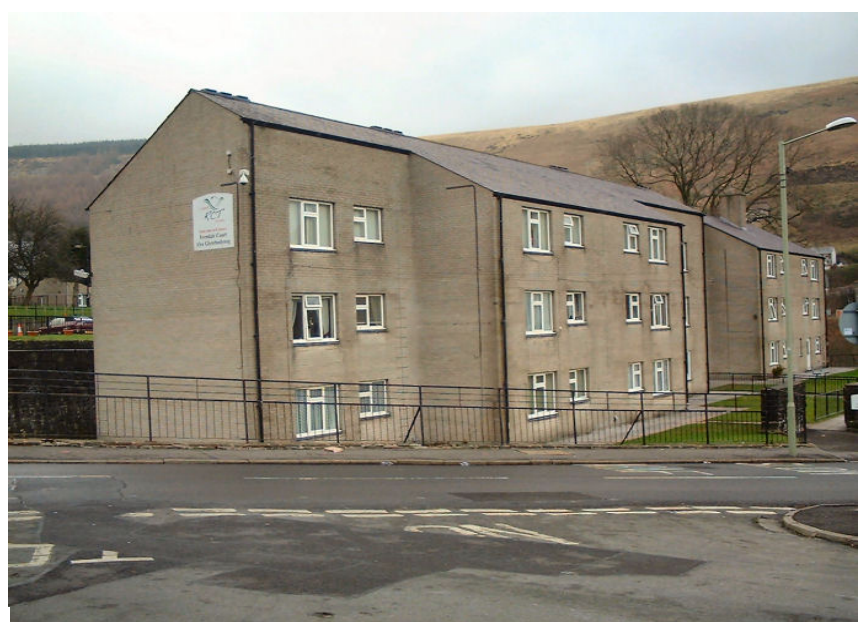
This 1970's purpose built block of flats recently developed cracking in the external skin of the traditional cavity constructed walls.

After a detailed survey of the entire building, the cracking was attributed to thermal movement due to the lack of any movement joints in the large panels of brickwork.

Cracking at high level on the gable elevations was caused by an insufficient number of wall ties employed in the original construction.

A detailed specification for the installation of full height movement joints at six metre intervals was provided. Helifix DryFix ties were installed adjacent to the movement joints to tie together the two skins of cavity brickwork. A twin bladed diamond cutter was then used to form chases for the debond sleeves and 6mm Helibar set in Polyplus resin.

Crack repairs were completed using 6mm Helibar and Helibond Grout. Additional DryFix wall ties were installed at high level in the gable walls.
