## Retaining Wall Repairs Gwaelod y Garth Lane, Merthyr Tydfil

Case Study No: 246

To repair this 20m long earth retaining wall that had begun to lean outwards towards the public highway and road.

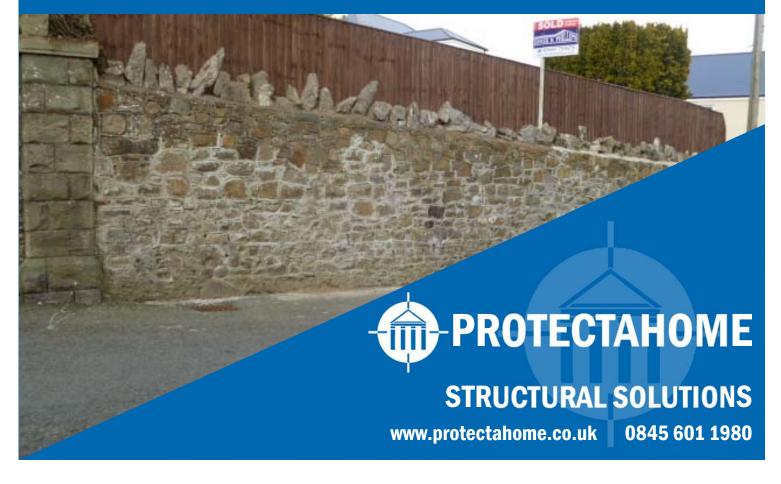
This 20m long earth retaining garden wall required strengthening and stabilisation to prevent further uncontrolled leaning.

The rotation had likely been caused by the presence of a soakaway in close proximity which had introduced hydraulic forces and softened the retained earth behind the wall.

It was noted that the wall did not have sufficient weep holes and had been repointed with sand and cement rather than a lime based mortar, which would have allowed to wall to dry naturally.

As the wall had begun to lean out onto a road, Protectahome were contacted by the building warranty provider to solve the problem.
