## STRUCTURAL REPAIRS - MONNOW BRIDGE, MONMOUTH

Case Study: 202

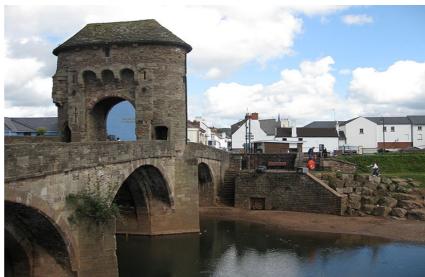
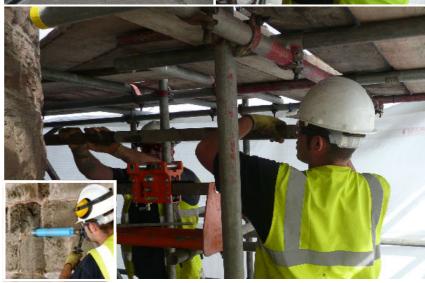
Once appointed, our directly employed structural repair technicians used specialist diamond drilling equipment to form voids into which the Cintec Anchors were installed. The anchor bodies included Cintec Multi Bar Anchors, Cintec Rebar Anchors and Cintec CHS Anchors all of which were grouted using Cintec non shrink Prestec Grout.

The cores removed during the drilling process were set aside and were subsequently rebedded in lime mortar for an almost invisible repair.
