Case Study : 140

PEST CONTROL—WAREHOUSE, GLOUCESTER

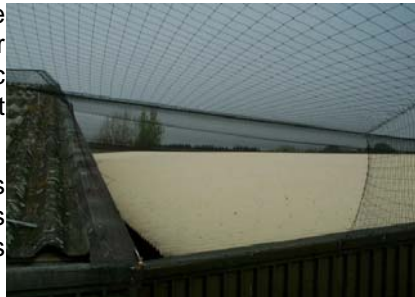
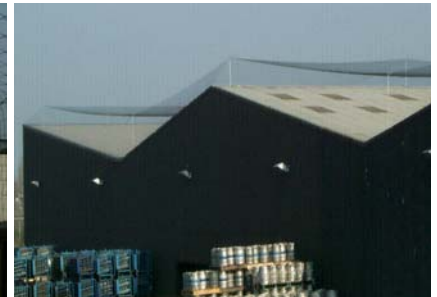
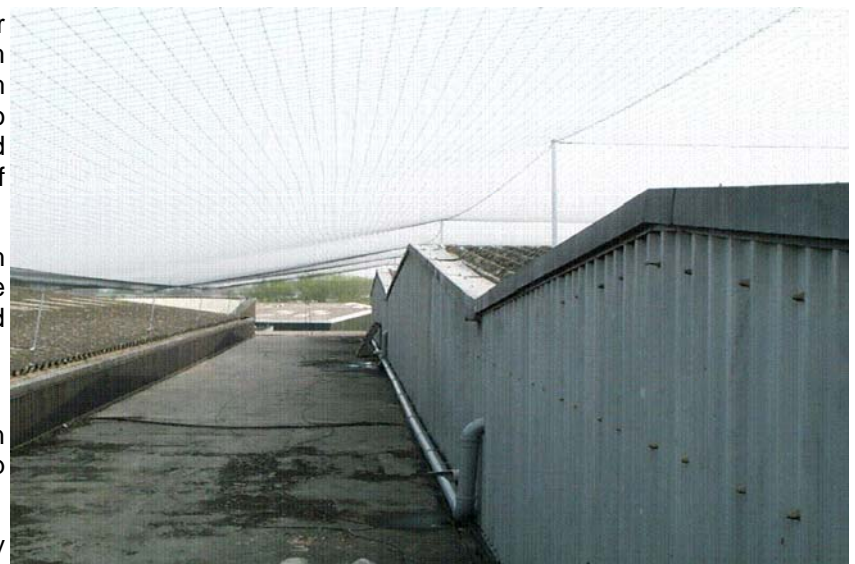
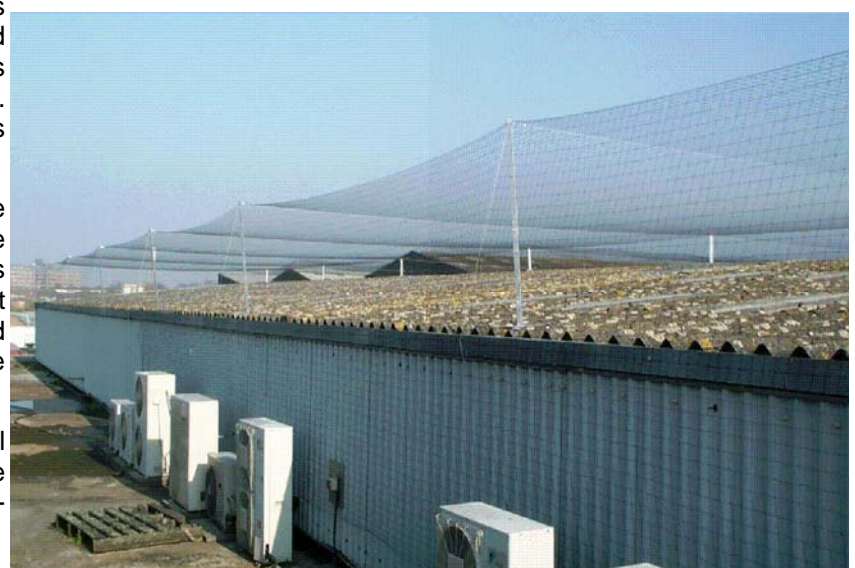
A problem had developed with gulls colonising the roof of the building. The gulls were causing damage to the roof as well as creating a health hazard due to fouling.

During very heavy rainfall during the summer months, the gull breeding season, debris from nesting and feeding was being washed from the roof into the gutters causing the gutters to block. This resulted in the gutters and downpipes overflowing and partial flooding of the distribution offices.

The Proofing employed a 75mm Gull net, fully UV light stable and rot proof. The net was suspended on stainless steel wires and fabricated steel poles across the entire roofs of the warehouses and distributions offices. The elevation of the net provides access beneath for building repairs and maintenance.

The Bird Proofing was carried out without the need for any closure of the building or the distribution yard, meaning that the client was able to go about their business without interruption. Protectahome's work prevented re-colonisation of the roof prior to the beginning of the breeding season.
