Case Study 165:

## CINTEC ANCHORS: GORLECH BRIDGE, CARMARTHEN

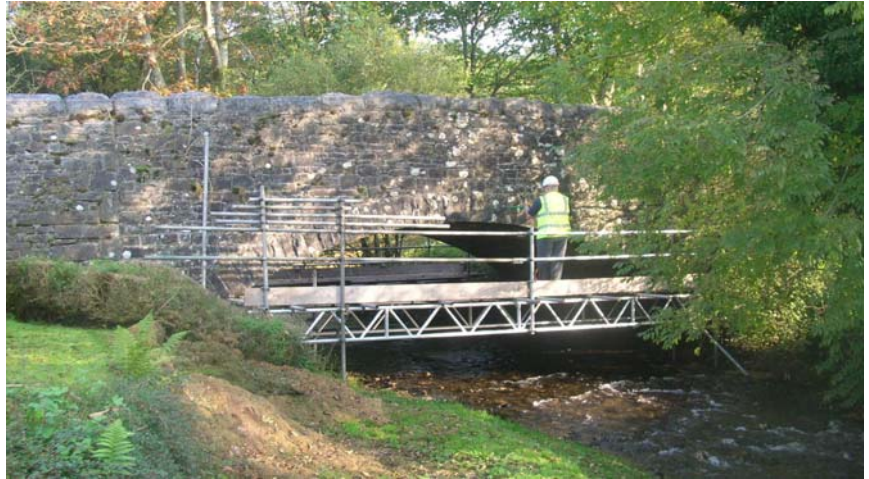
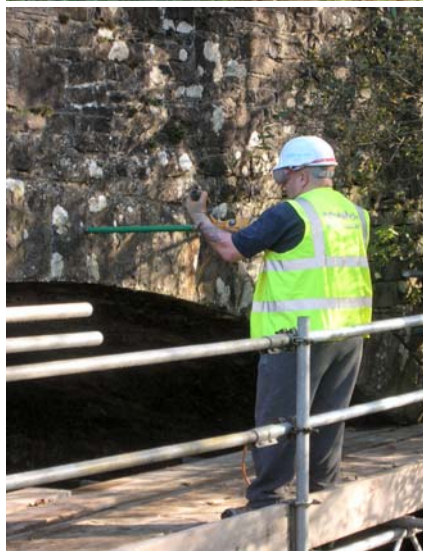
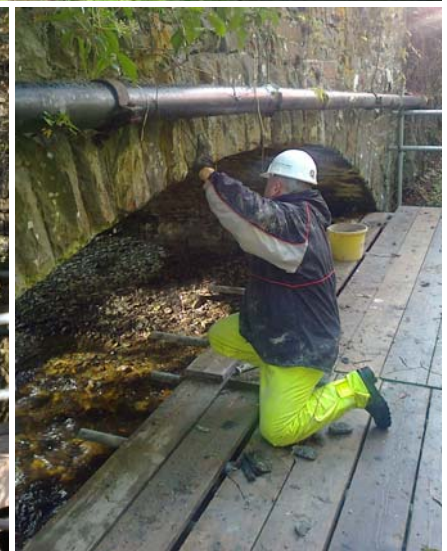
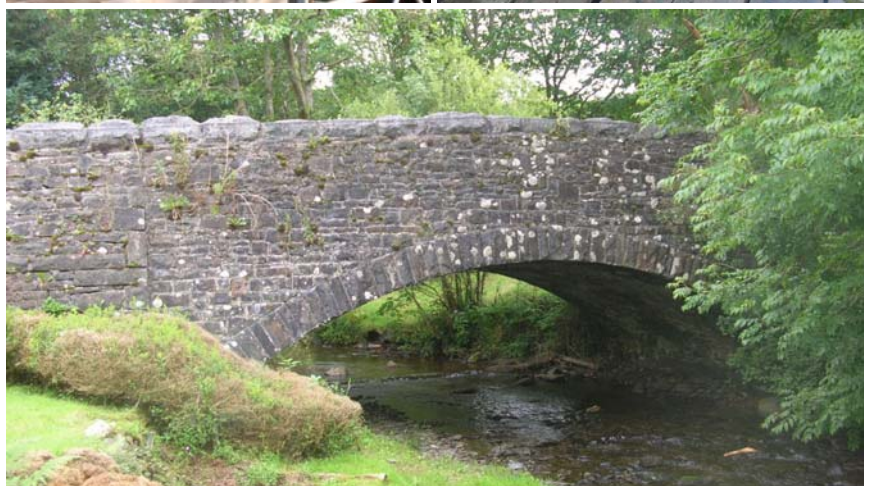
Concerns were raised about significant cracks that had developed through the bridge. The spandrels were separating from the soffit of the bridge and deep cracks had formed approximately 500mm in from the external face.

Our scaffold design allowed for a fully suspended work deck above the river. From this platform our technician's core drilled holes through the spandrels and installed Cintec RWT anchors 1200mm long. Upon completion, the cores were rebedded for an almost invisible repair. The main crack was improved using a lime based mortar.
