Case Study 164:

CINTEC ANCHORS: THE STABLE RANGE AND LODGINGS

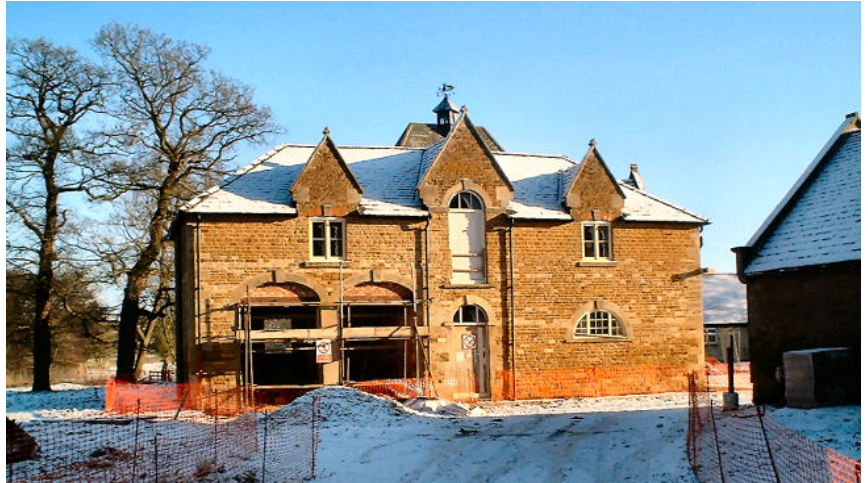
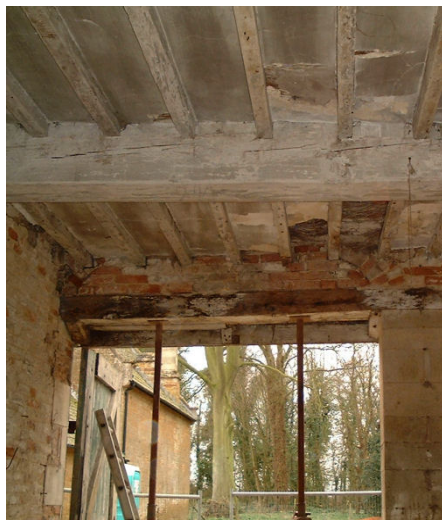
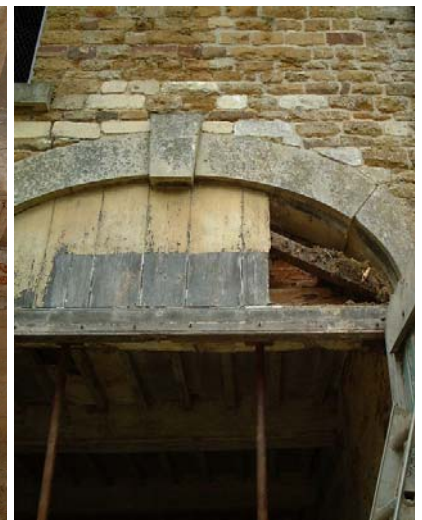
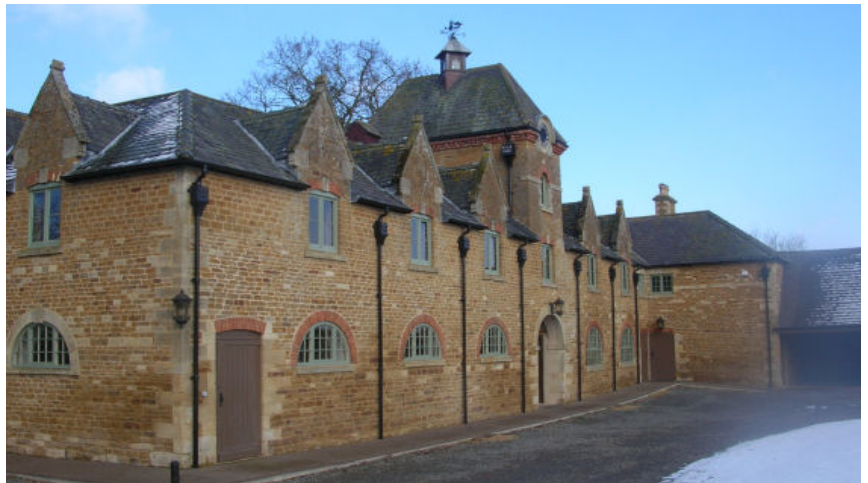
The Stable Range and Lodgings are set within the grounds of Edmondthorpe Hall in Leicestershire. These historical Grade II listed buildings with Ashlar stone dressings and Swithland slate roofs, were suffering from structural cracking affecting several external walls.

Following a detailed inspection, we identified that the external walls needed tying back to the internal walls and corner stitching would be required. In addition, the main double doors giving access to the stable had a defective timber lintel.

A schedule of repairs was prepared that incorporated the use of the Cintec Anchor System. A series of anchors were installed into the structure using diamond drilling equipment which left little visible evidence on the surface of the walls once the cores were replaced and repointed.

The anchor system included for Cintec RWT anchors ranging from 400mm to 3.1 metres in length. A total of 68 anchors were installed by our own highly skilled and experienced technicians.

The anchors were designed, arranged and installed in a manner that allowed for the defective timber lintel to be retained in situ. This minimised the distress to the building and created a resultant time and cost saving.
