Case Study 075:

HELIFIX REPAIRS: ROYAL COTTAGES

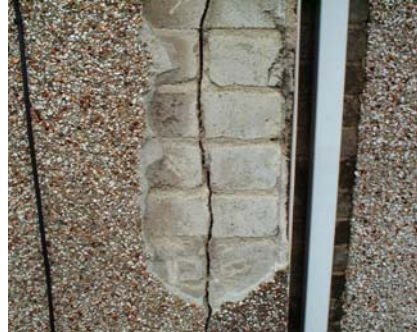
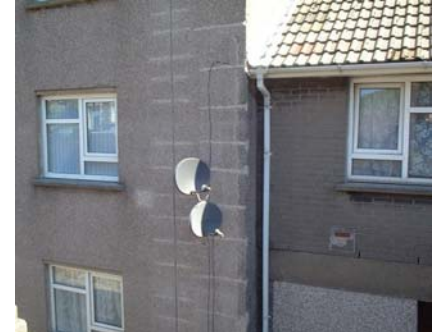
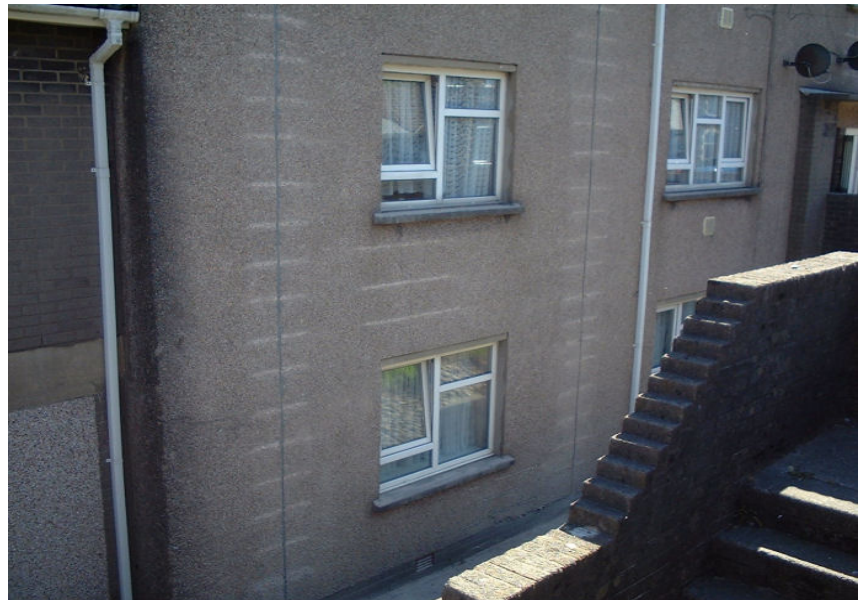
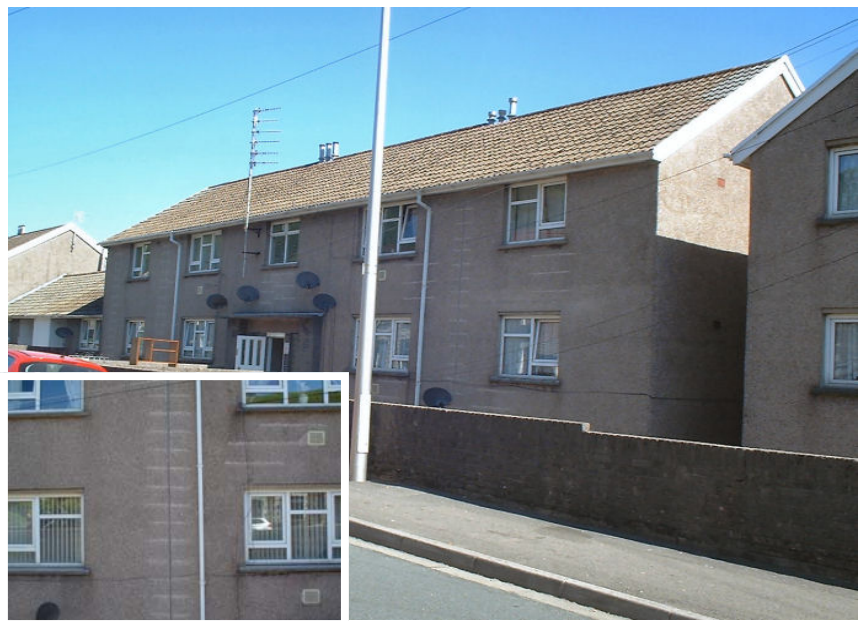
External structural cracking recently appeared in a 1970's two and three storey flat development of traditional cavity construction.

After a detailed survey of the entire building, the cracking was attributed to thermal movement due to the lack of any movement joints in the large panels of brickwork.

A detailed specification for the installation of full height movement joints at six metre intervals was provided.

Helifix DryFix ties were installed adjacent to the movement joints to tie together the two skins of cavity brickwork. A twin bladed diamond cutter was then used to form chases for the debond sleeves and 6mm Helibar set in Polyplus resin.

Existing cracks were repaired using 6mm Helibar and Helibond grout.
