Case Study 166:

CINTEC ANCHORS: ABERSANNAN BRIDGE, CARMARTHEN

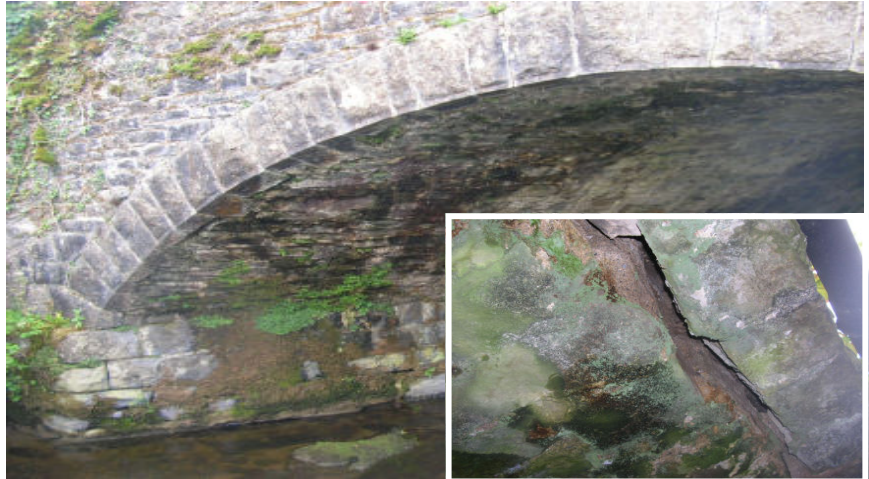
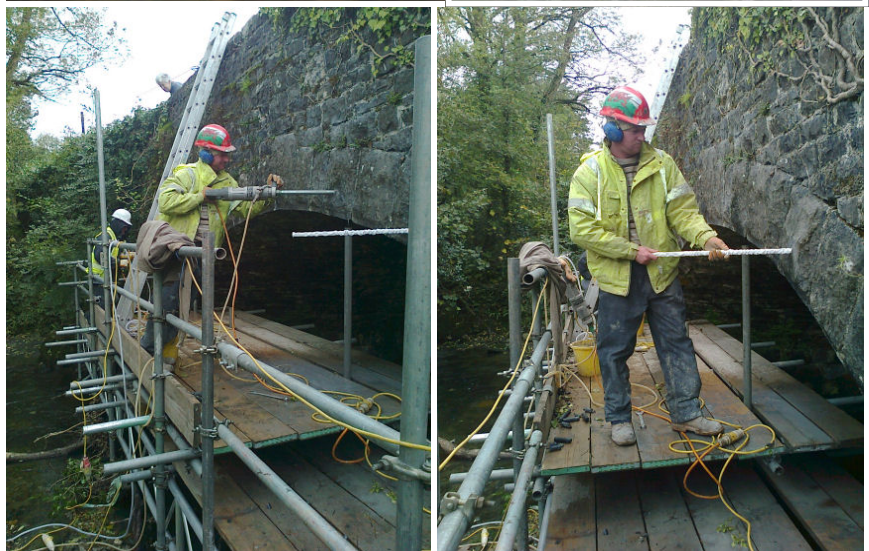
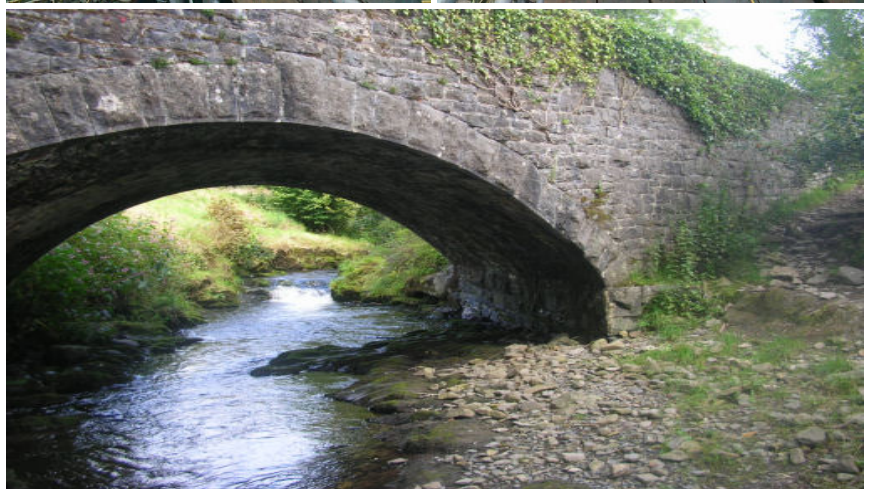
Significant cracks had developed in the bridge causing great concern. The cracks were attributed to spandrels separating from the soffit of the bridge.

Our scaffold design provided for a fully suspended deck above the river. From this platform our technician's core drilled holes through the spandrels and installed Cintec RWT anchors 1200mm long. Once the anchors had cured, the cores were rebbed for an almost invisible repair. The main cracks were improved using a lime based mortar and grout.
