PROTECTAHOME LTD STRUCTURAL SOLUTIONS

Case Study 07:

CINTEC ANCHORS: WITLEY COURT, WORCESTERSHIRE

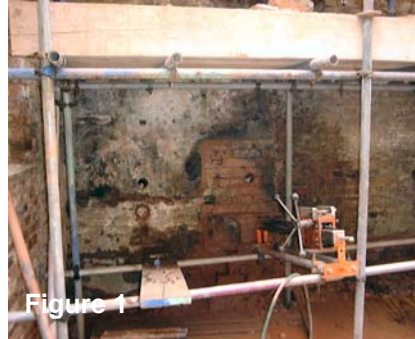
Figure 1

The anchors were installed using a Hydraulic drill head and diamond core bits mounted on a specially adapted rig fixed to the scaffolding, Figure 1. The use of this equipment enabled the anchors to be installed at predetermined angles into the rock beyond the retaining wall.

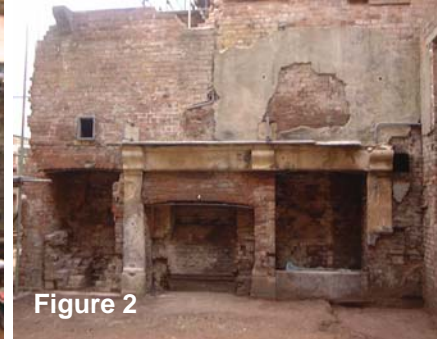
Figure 2

Cintec RAC anchors were used to stabilise and secure fire places in their original positions, Figure 2.

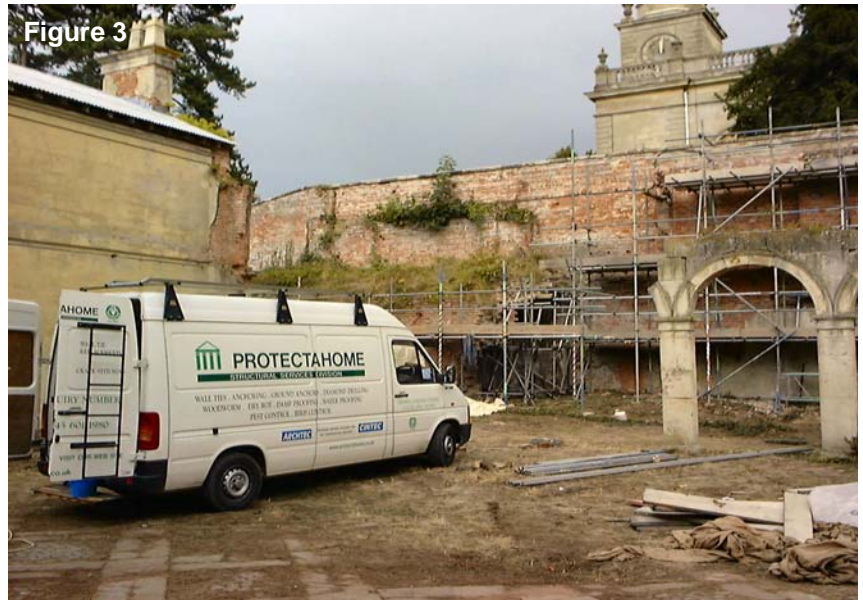
Figure 3

Cintec Rebar Anchors 3.5 metres long were introduced into the earth retaining walls of the Churchyard, Figure 3.
