Case Study 172:

HELIFIX REPAIRS: LLOYD ST, HEREFORD

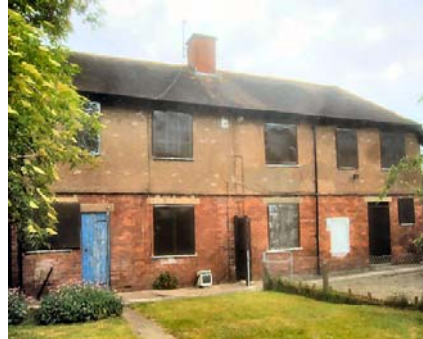
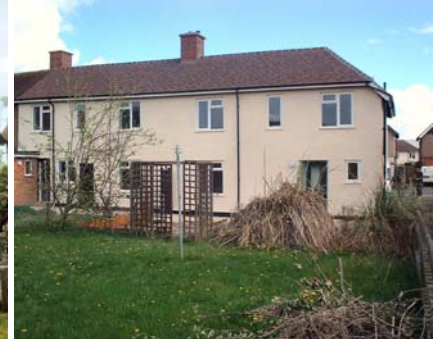
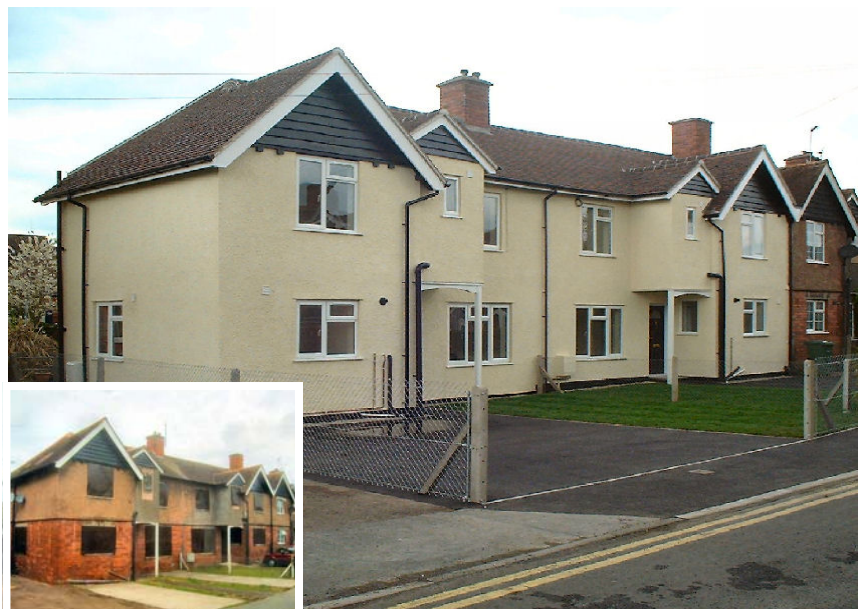
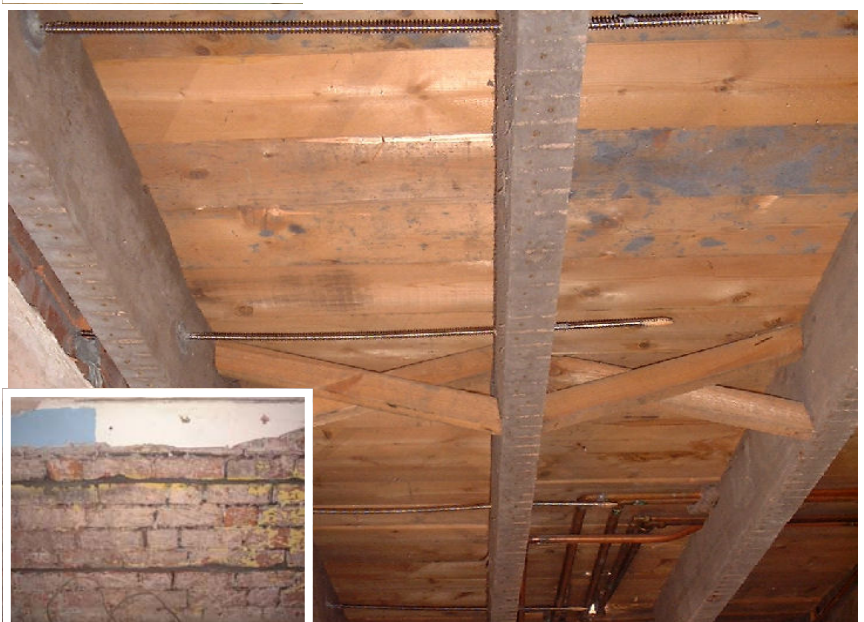
A pair of terraced houses of traditional, brick cavity construction owned by a local social housing provider. The houses were suffering from historical structural movement. This movement was particularly noticeable to the rear elevation where the wall was found to be badly cracked and leaning. The buildings had stood empty for a number of years and were scheduled for major refurbishment and reoccupation.

The external walls were tied back to the party walls using 900mm Helifix CemTies. A double chord Helifix HeliBeam was formed below the ground floor windows to the full perimeter of the properties, in both the external and internal skins of brickwork.

Using the timber first floor as a diaphragm, the front, rear and gable elevation walls were connected using Helifix HD BowTies. This provided much needed lateral restraint at intermediary level.

A further Helifix twin chord HeliBeam was installed at first floor level on the rear elevation. Finally, Crack Stitching was carried out using 6mm Helifix HeliBar bedded into HeliBond Structural Grout.
