PROTECTAHOME LTD WATERPROOFING SOLUTIONS

Case Study 09:

STRUCTURAL WATERPROOFING - BARN CONVERSION, KIPSCOMBE

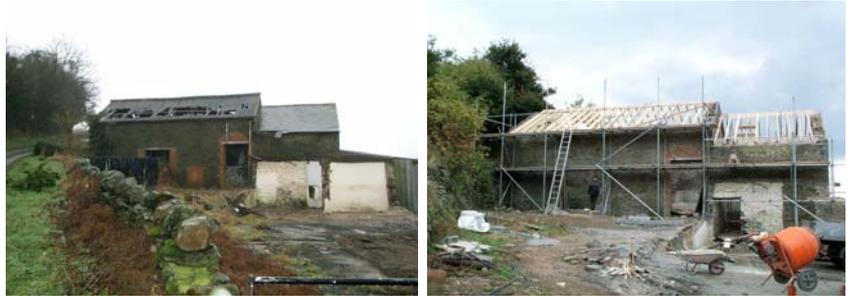
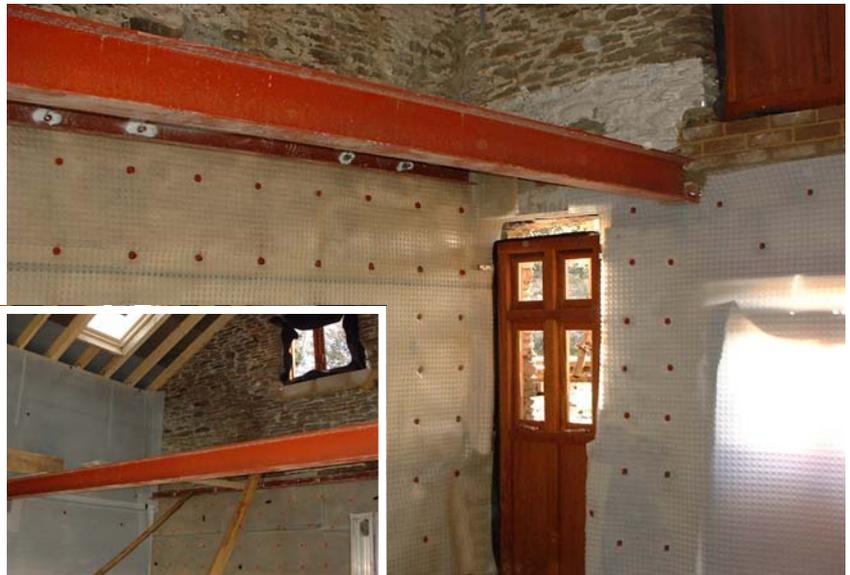
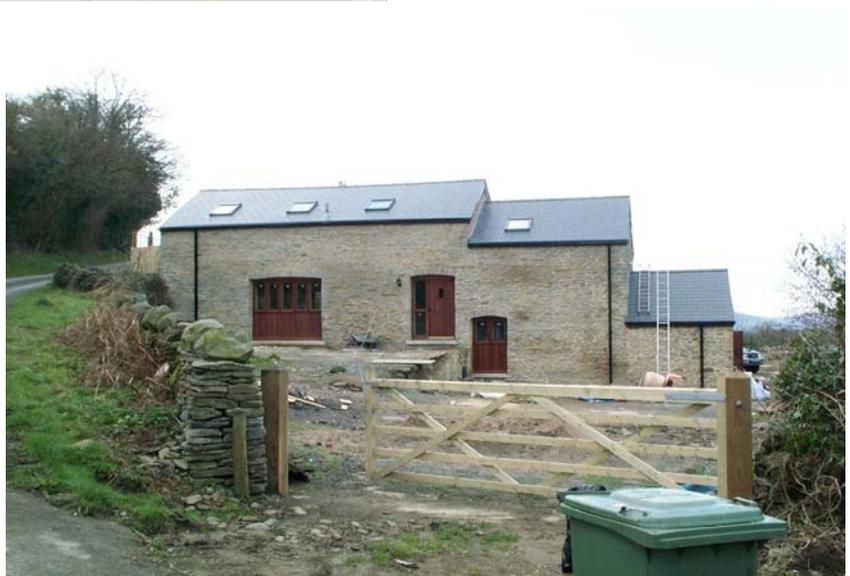
The Barn is built on split levels meaning a number of the walls are earth retaining and suffering from ground water ingress. Years of neglect and lateral rain water penetration had led to structural problems, whilst the housing of livestock was responsible for high levels of contamination in the structure, including nitrates and uric acid.

Having dealt with Structural Repairs and Stabilisation using a bespoke system of Anchoring and Consolidation, we began the process of installing a Drained Protection Waterproofing System. The Waterproofing was applied to the full height of the barn, providing additional protection against future lateral rain water penetration.

This type Waterproofing uses the Barn and its structure as a host for the internally applied Waterproofing and the finishes. Barn Conversions offer unique challenges, the correct specification and use of specialist Membranes can eliminate problems typically associated with traditional Tanking such as debonding, salting and delamination.
