## STRUCTURAL REPAIRS – BERTRAM STREET, CARDIFF

Case Study: 210

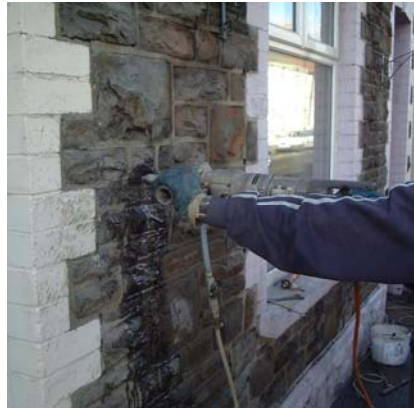
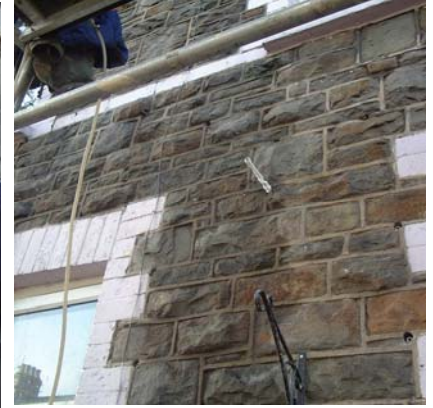
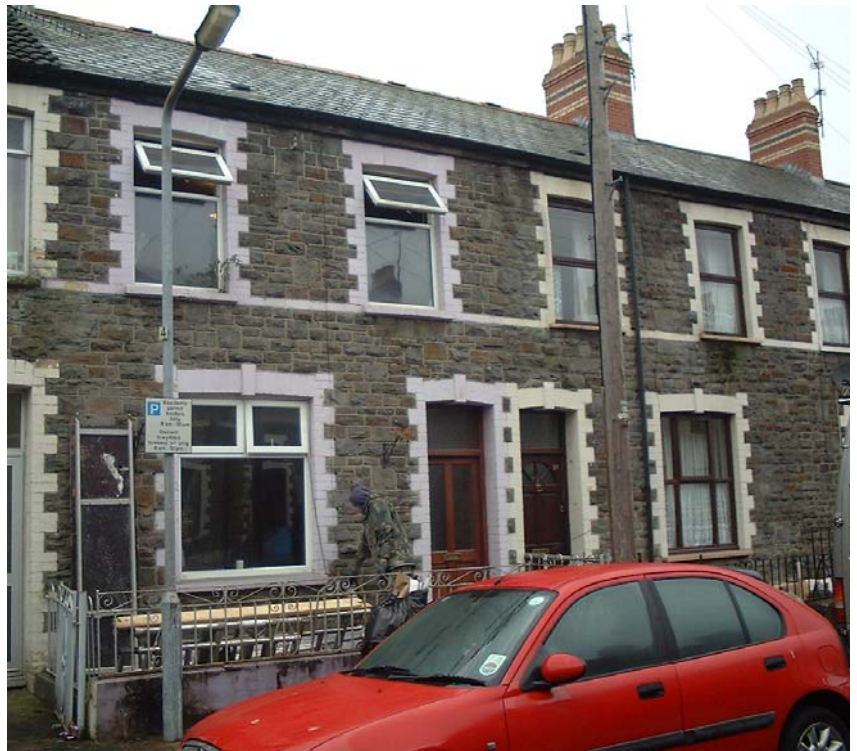
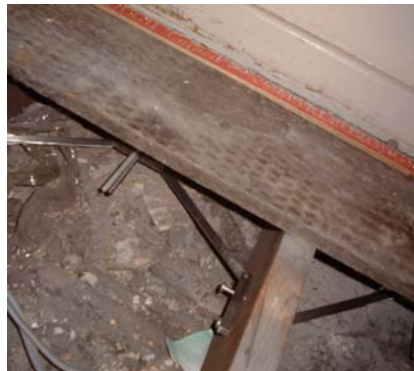
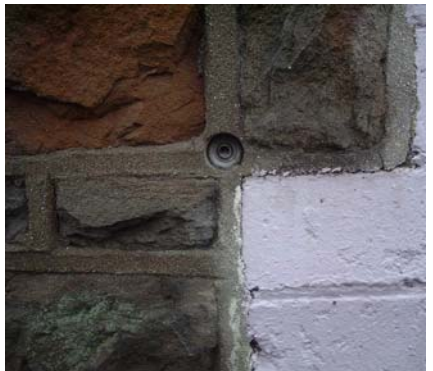
Constructed of 450mm dressed local Pennant sandstone, laid in black ash mortar with decorative brick quoins, the wall displayed a lack of lateral restraint. Consistent with this, inspection discovered a bulge at first floor level. There was also evidence present of debonding of the two skins of stone work.

Our structural repair technicians installed a total of 75 Cintec anchors including 375mm Cintec RAC consolidation anchors to the complete front elevation.

Before the anchors were installed, wet core drilling was used to create 25mm diameter holes. An anchor with a grout sock was inserted into the holes and Presstec cementitious grout was injected to inflate it.

375mm stud anchors, which were fitted with threaded bar, were fixed at first floor level. Arm locks were fitted to these, connecting them to every other first floor joist. This provided the much needed lateral restraint.

In addition to these structural repairs, the ground floor wall between the hall and the lounge showed signs of cracking and required Helifix crack stitching. Protectahome's structural repair technicians installed 5m of Helibar to repair this.
