# Timber Beam End Repairs Clyne Castle, Swansea

## Case Study No: 101

- Roof Timber Beam Repairs
- Epoxy Resins
- Listed Building Repairs

To undertake a series of sympathetic roof timber repairs to this grade II listed castellated mansion as part of a wider refurbishment.

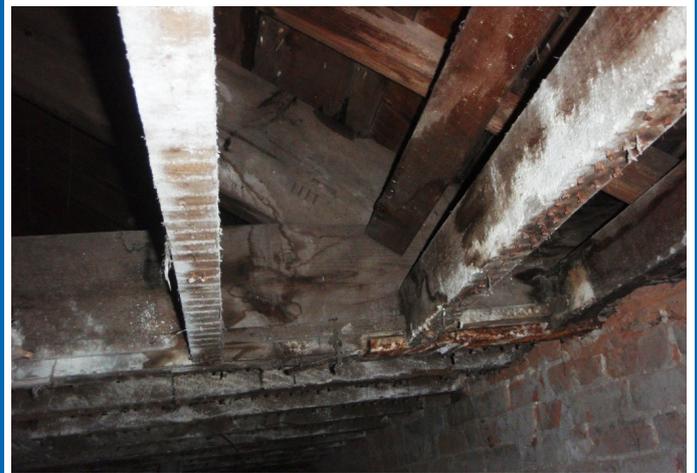
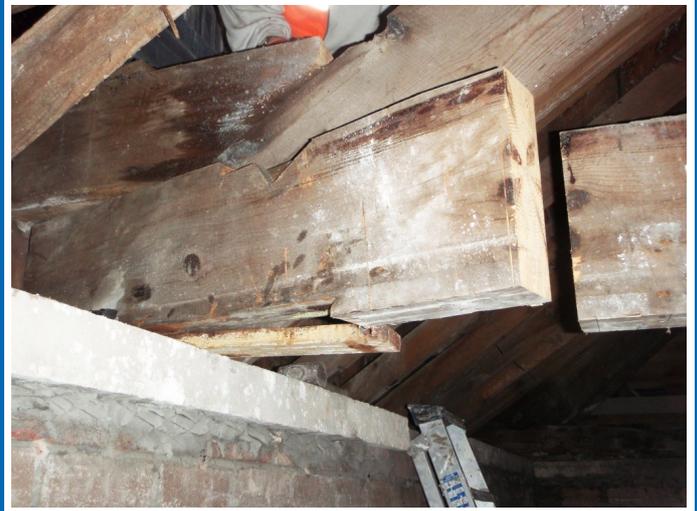
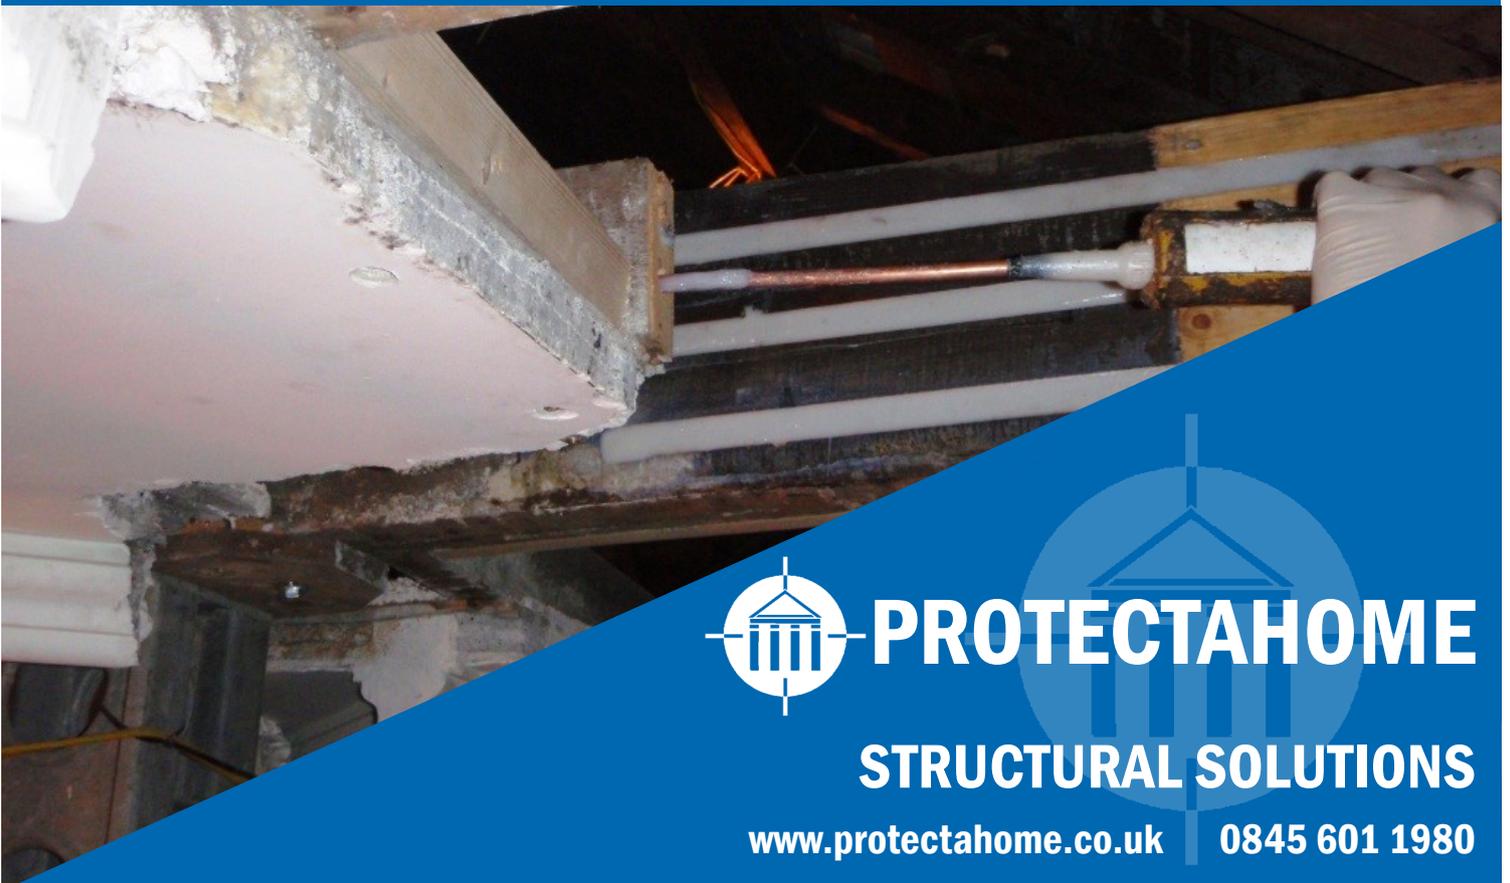
During the latest refurbishment, due to prolonged water ingress through the lead sheeting roof valley gutter, a significant attack of wet rot fungus was found to have caused substantial damage to roofing timbers with hip rafters, span beams and ceiling joists all badly affected.

For both economical and conservation reasons, removal of the roof covering was not possible so Protectahome were tasked, working alongside the project engineer, to undertake a series of sympathetic timber repairs that not only negated the need for a costly roof removal but also preserved as many of the period features as possible, such as the ornate lath and plaster ceiling below.

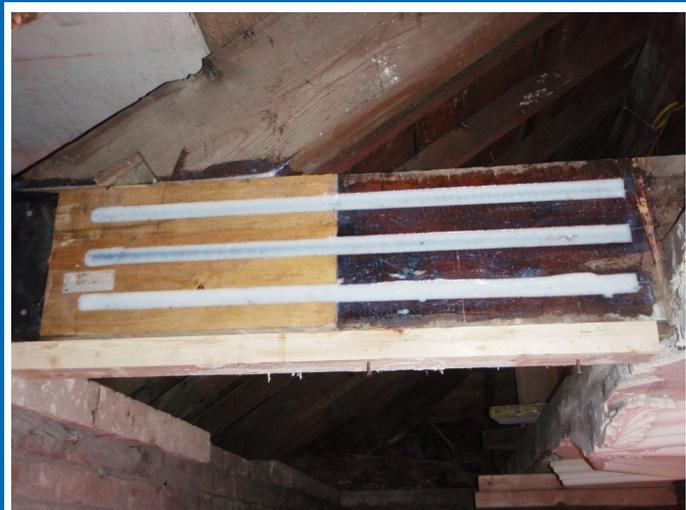
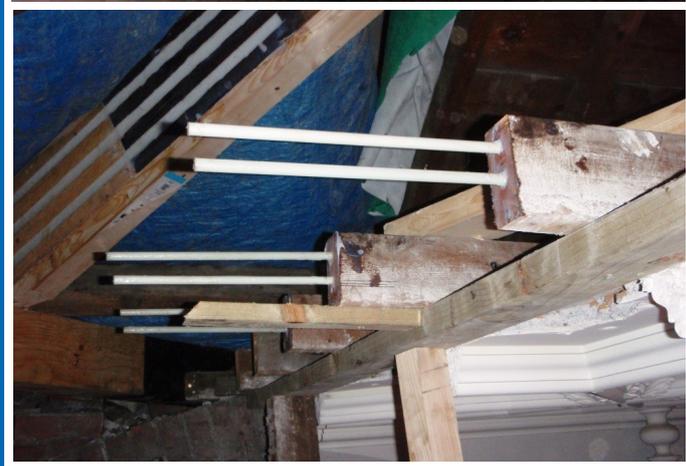
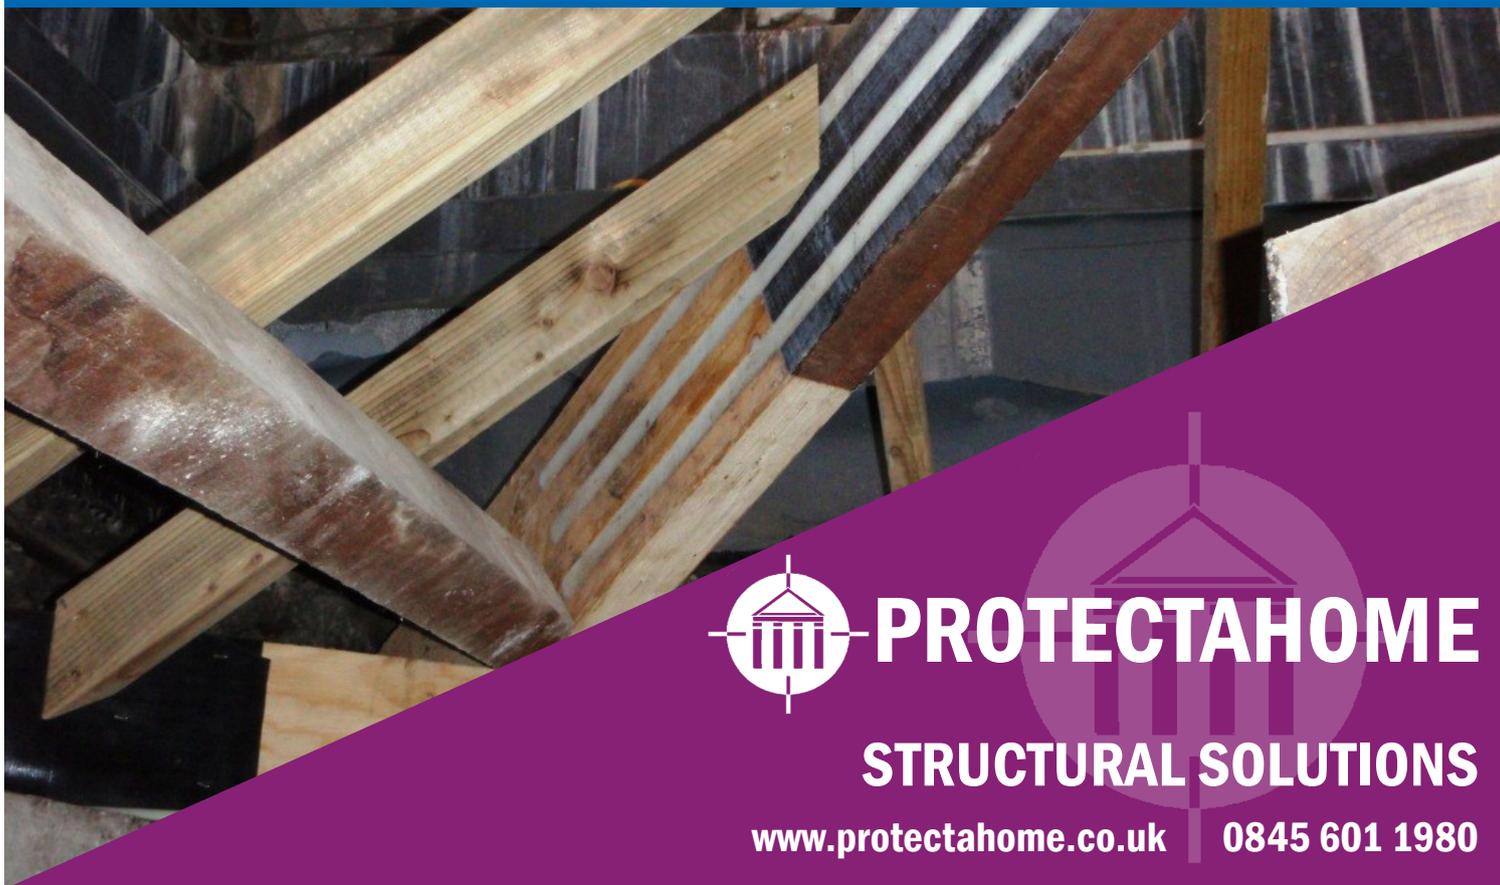
Unsalvageable timber, largely from damaged bearing ends, was cut away and replaced with new whilst a number of 16mm diameter high tensile rebar was installed via side slot design and bonded in specialist timber resin to provide the necessary structural integrity to both parent and new timber.

Replacement span beams were installed and bonded with the repaired hip rafters using 20mm diameter rebar and specialist timber resin.

In ceiling joist timbers, 12mm glass fibre reinforced plastic rods were bonded into the end of parent timbers before new replacement was added and isolated from the wall surfaces.
