Lateral Restraint

Solid Stone Cottage, Goat Street, St Davids, West Wales

Case Study No: 244

Goat Street, St Davids - The Problem

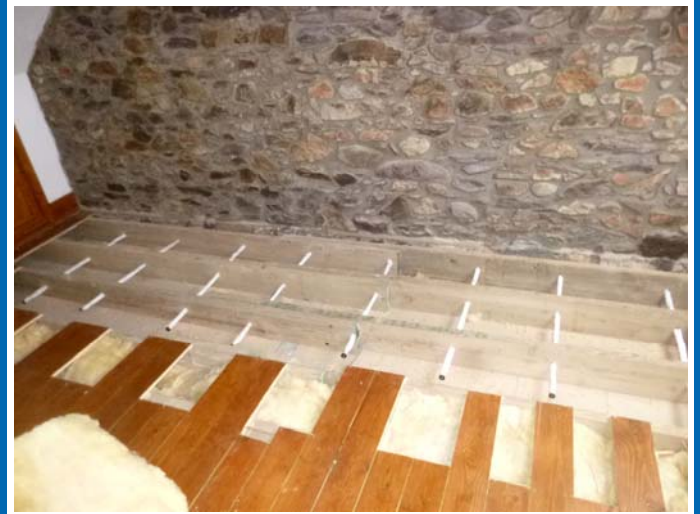
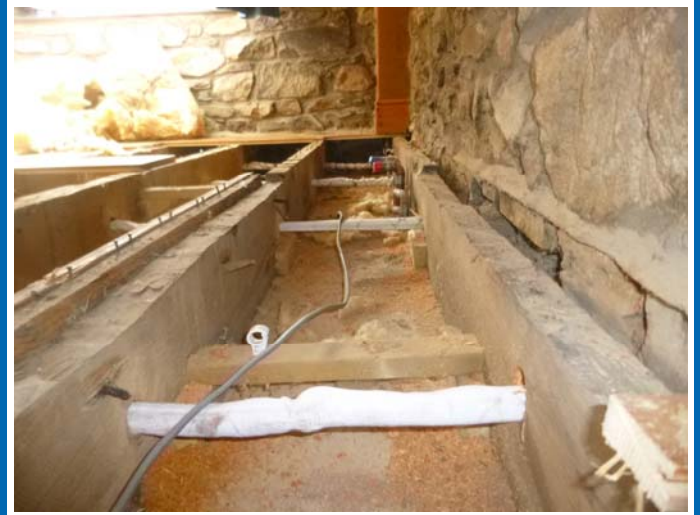
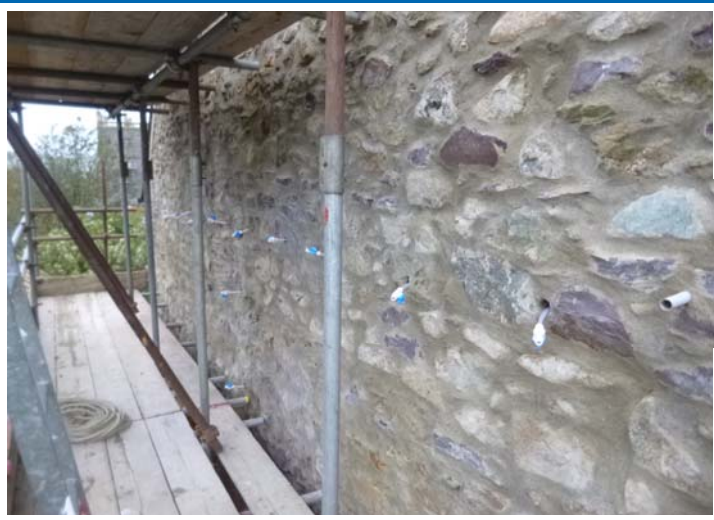
This 150 year old, semi-detached property was suffering from separation between the gable end wall and the front and rear elevations at 1st floor and attic floor levels. The property, located in St Davids, West Wales, the smallest city in the UK, is currently used as a holiday home in the popular tourist area.

The outward movement of the 650mm thick, rubble filled, solid stone gable wall, was due to a lack of lateral restraint and had become apparent during renovation works where the removal of the roof to an adjacent single storey structure may have reduced lateral support for the wall further.
