# New Build Visitor Centre Llandegfedd Reservoir Monmouthshire, South Wales

## Case Study No: 251

- New Build Waterproofing
- Type C (Drained) Protection
- External Depressurising Drainage Layer

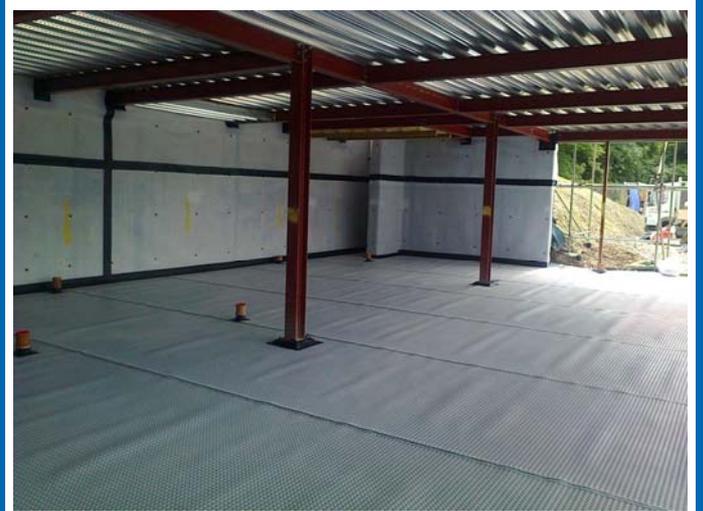
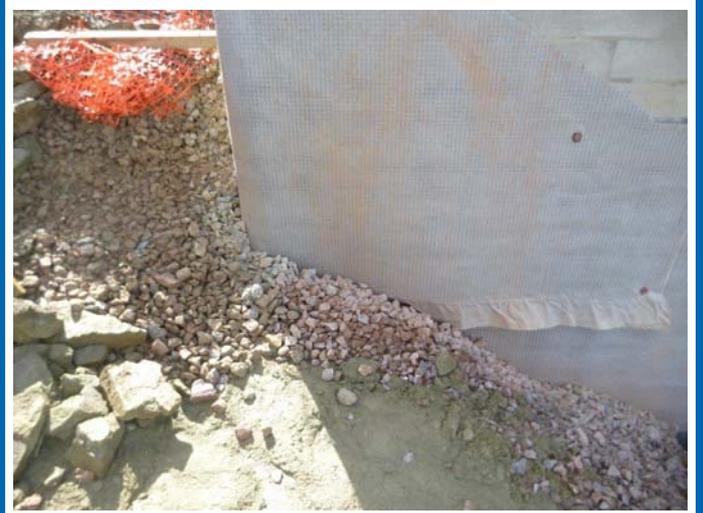
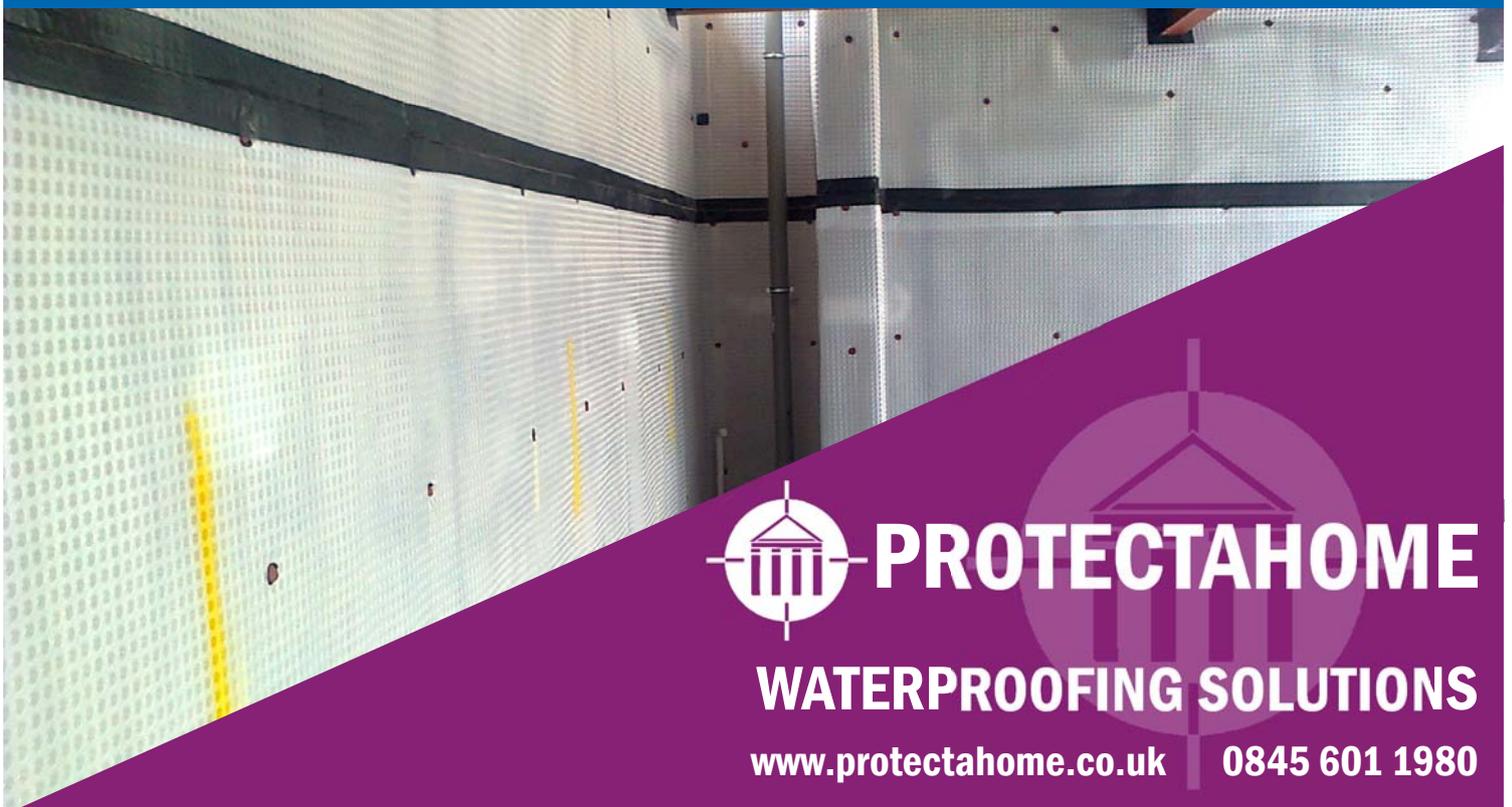
The pre-designed waterproofing system combined a Type C (Drained) protection with an external depressurising drainage layer.

Externally, a specially designed two component drainage membrane was installed along the earth retaining side and rear elevations. As part of the specification, a land drain and clean, free draining stone were installed by the main contractor to supplement the external drainage layer.

8mm Cavity Drain Membrane was installed to the internal wall surfaces and the floor slab to capture any free water that may penetrate the structure.

A drainage channel was formed in the perimeter of the floor slab at the wall/floor junction to accommodate the installation of periphery drainage channel that would redirect any free water from behind the membranes to a safe point of disposal.
