Stabilisation, Consolidation & Crack Repair

Barn Conversion to B&B Accommodation Usk, Monmouthshire

Case Study No: 261

Barn Conversion, Usk - The Problem

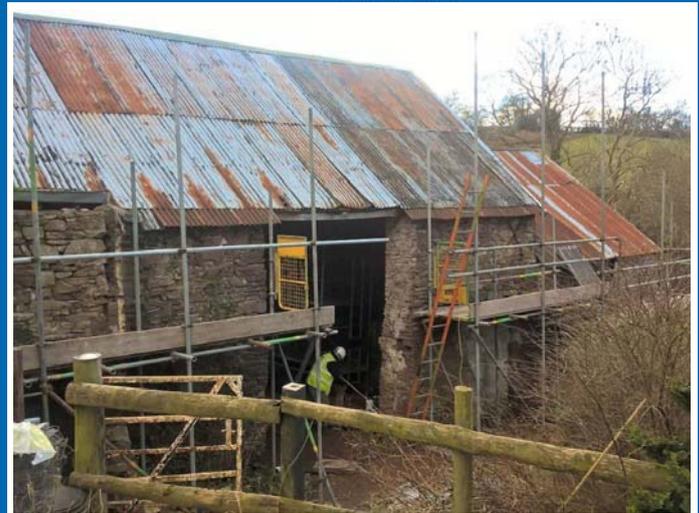
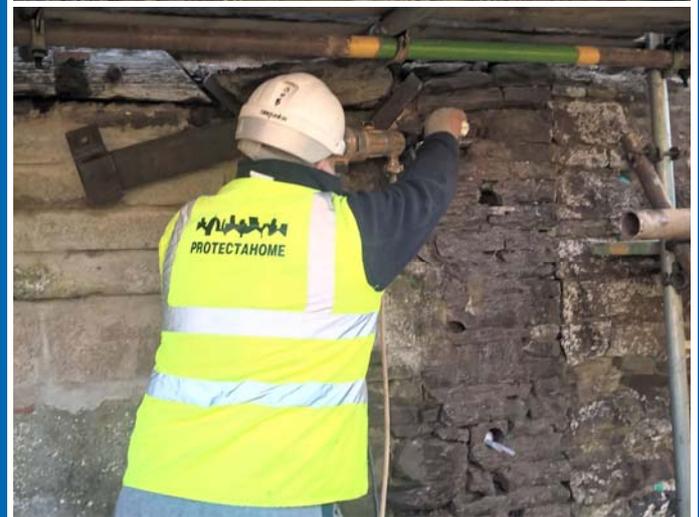
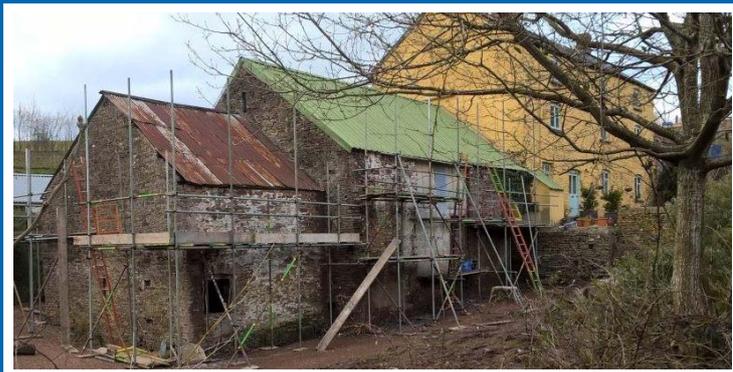
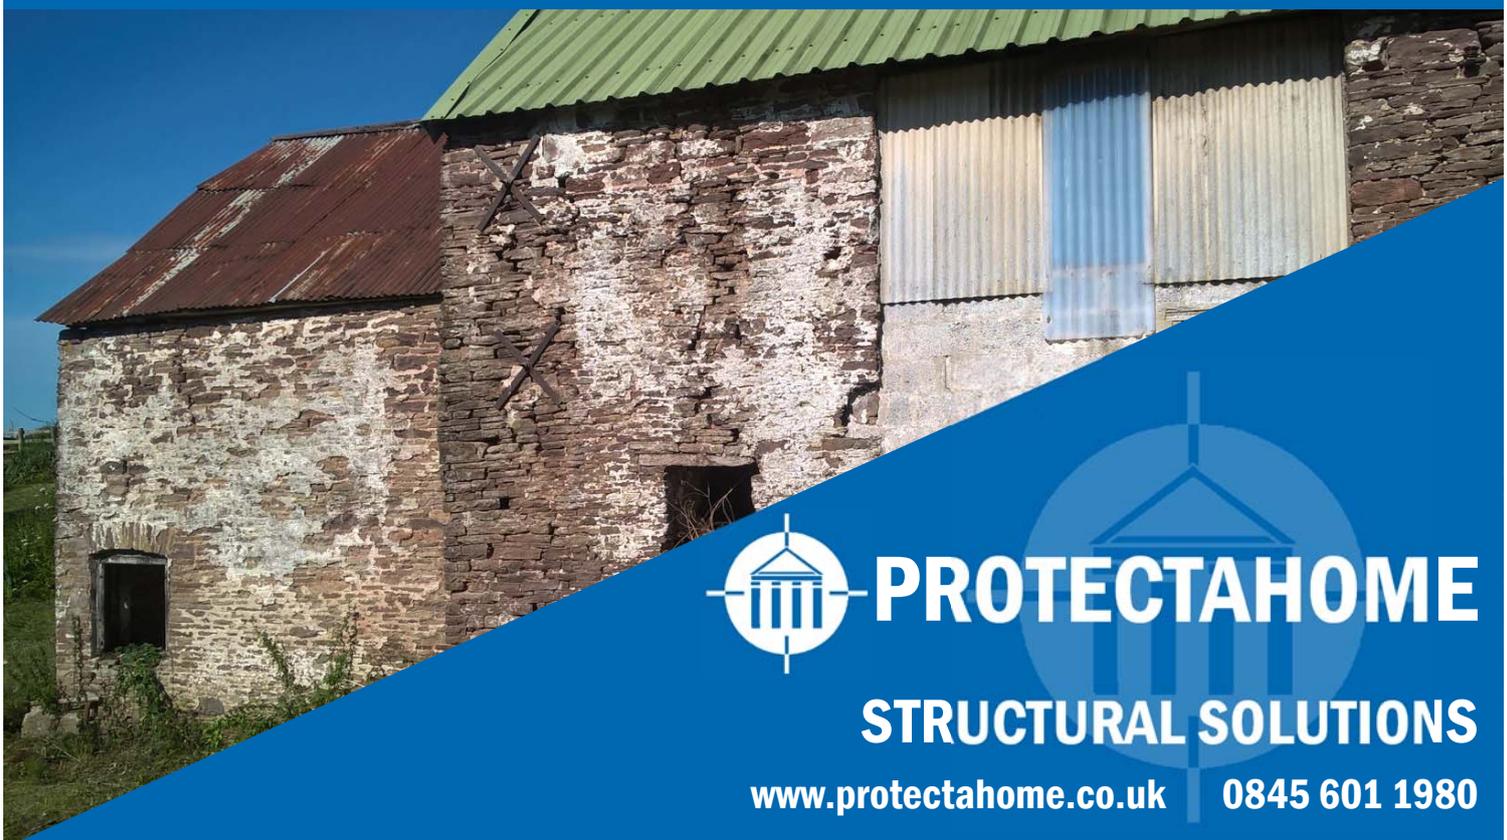
The primarily solid stone adjoining barn structures were suffering from historic movement which had caused a number of significant structural challenges including delamination, cracking and bowing of several elevations.

In order for the barns to be made safe for development, extensive structural repair works were required to stabilise and consolidate the existing structure.

Working in conjunction with the structural engineer, a scheme of Cintec Anchoring was devised that would provide the necessary remedial strengthening to the barns.
