Movement Joints & Crack Stitching Verallo Drive, Cardiff

Case Study No: 262

The Project:

To repair existing cracking as a result of thermal movement and install addition movement joints to this brick built residential accommodation complex.

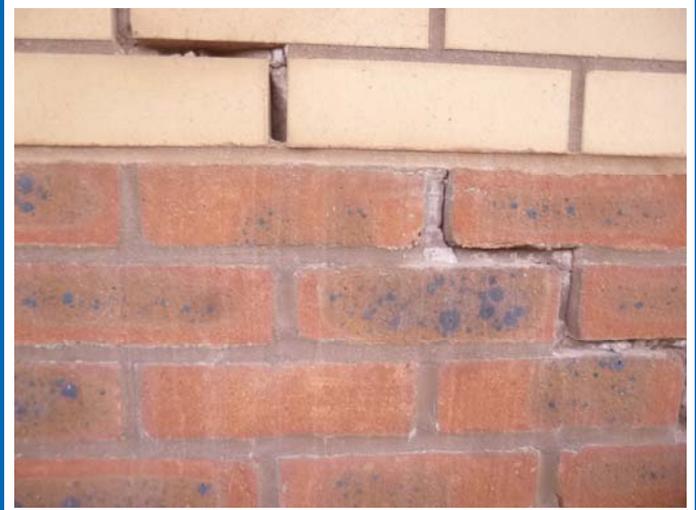
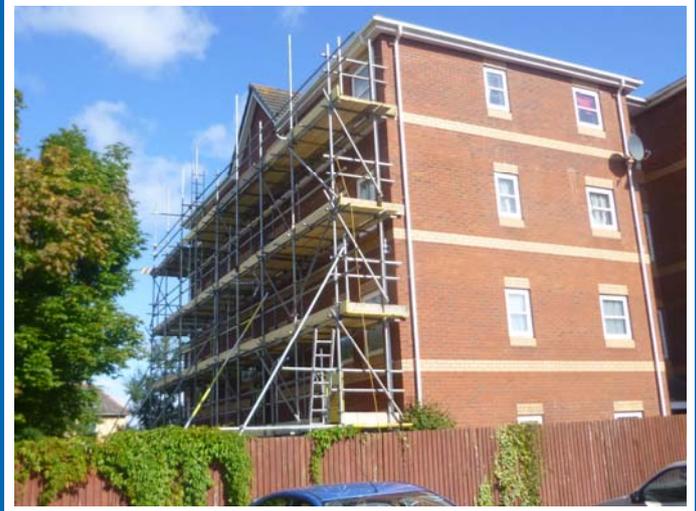
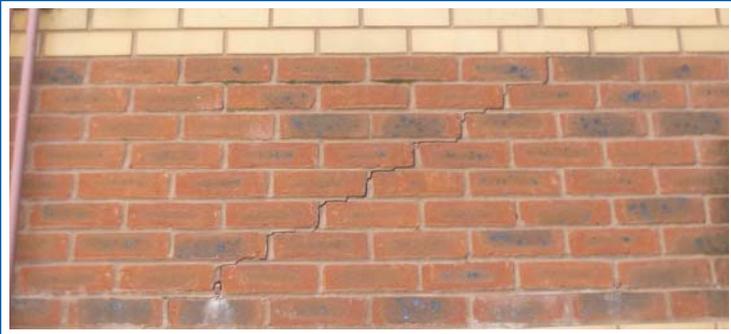
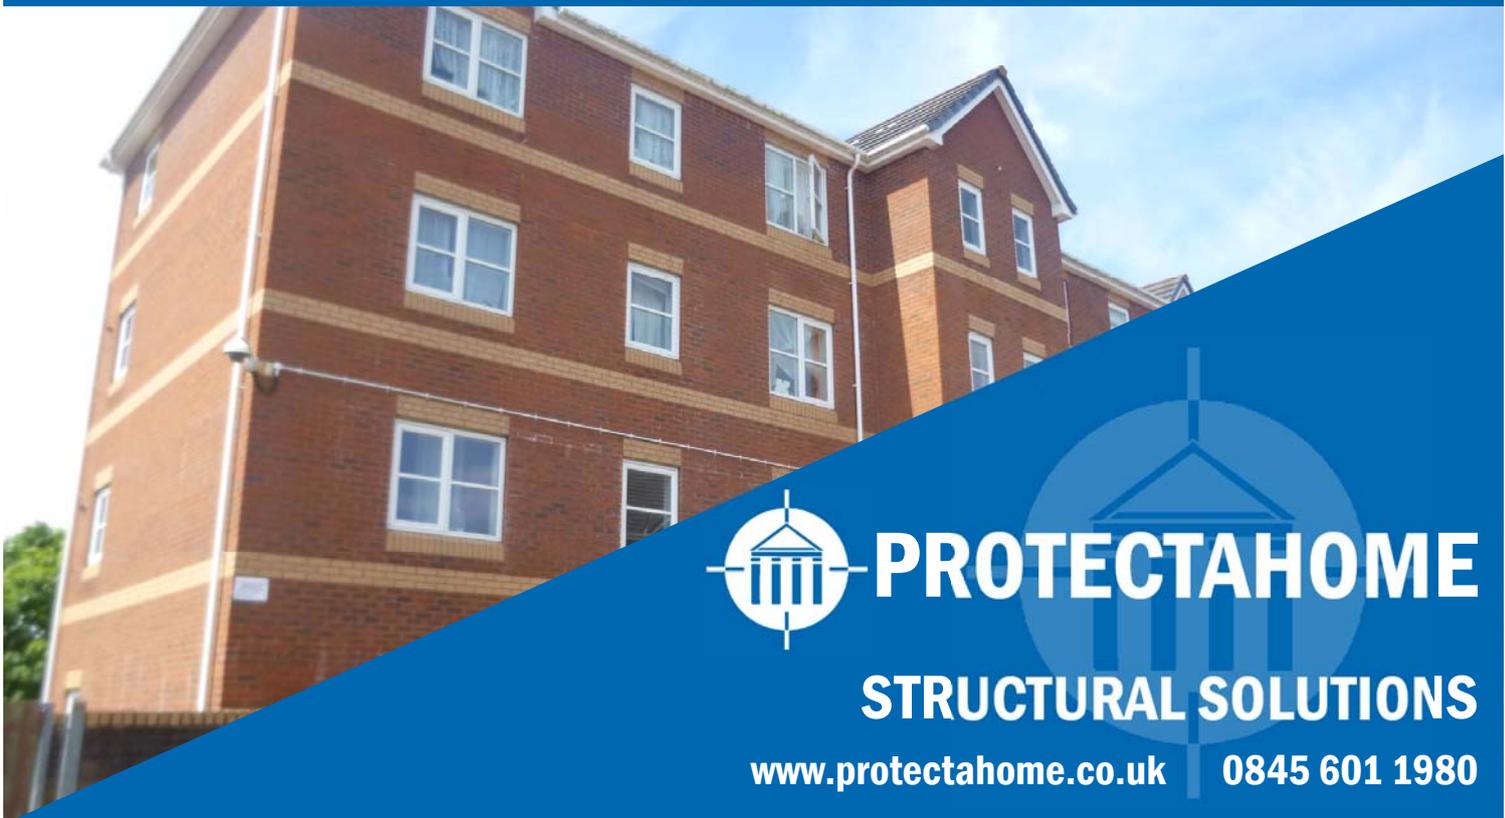
This four storey Housing Association accommodation of brick cavity construction, was suffering from cracking to the rear elevation as a result of thermal movement and an insufficient number of movement joints installed during construction.

As was the case here, thermal movement often occurs to elevations that receive large amounts of direct sunlight throughout the day. The sunlight causes the temperature of the elevation to rise and slight expansion movement to occur. If adequately installed movement joints are not present, this can lead to cracking on the elevation.

Protectahome were selected as the contractor to undertake the remedial works that involved installing additional movement joints to the full height of the elevation and installing close to 300m of Helifix HeliBar to repair several cracks and strengthen lintels across the elevation.
