Structural Anchoring Westminster Abbey, London

Case Study No: 284

To repair several large cracks that had appeared within a medieval wall on the grounds of the historic Westminster Abbey.

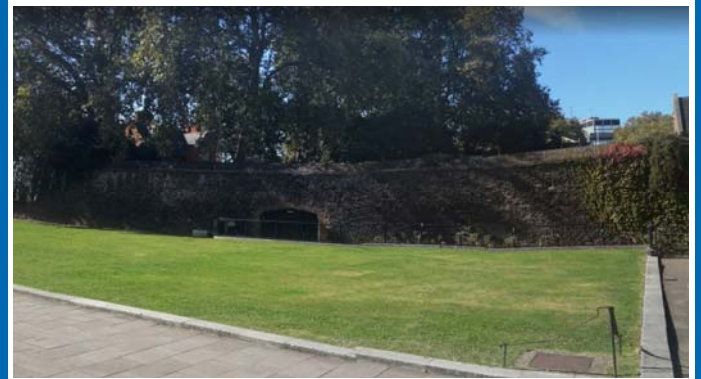
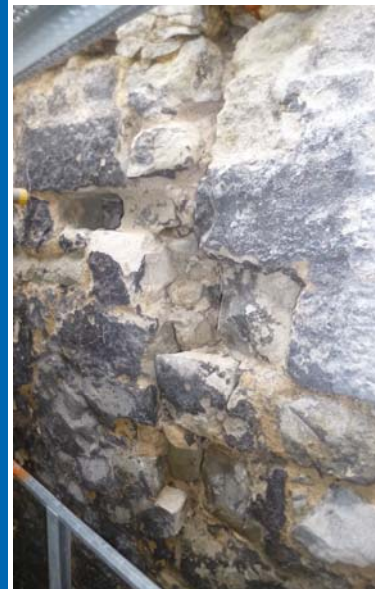
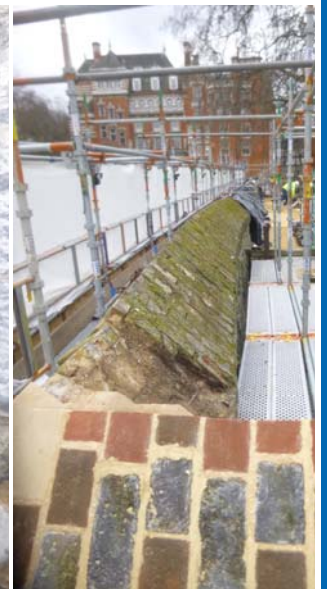
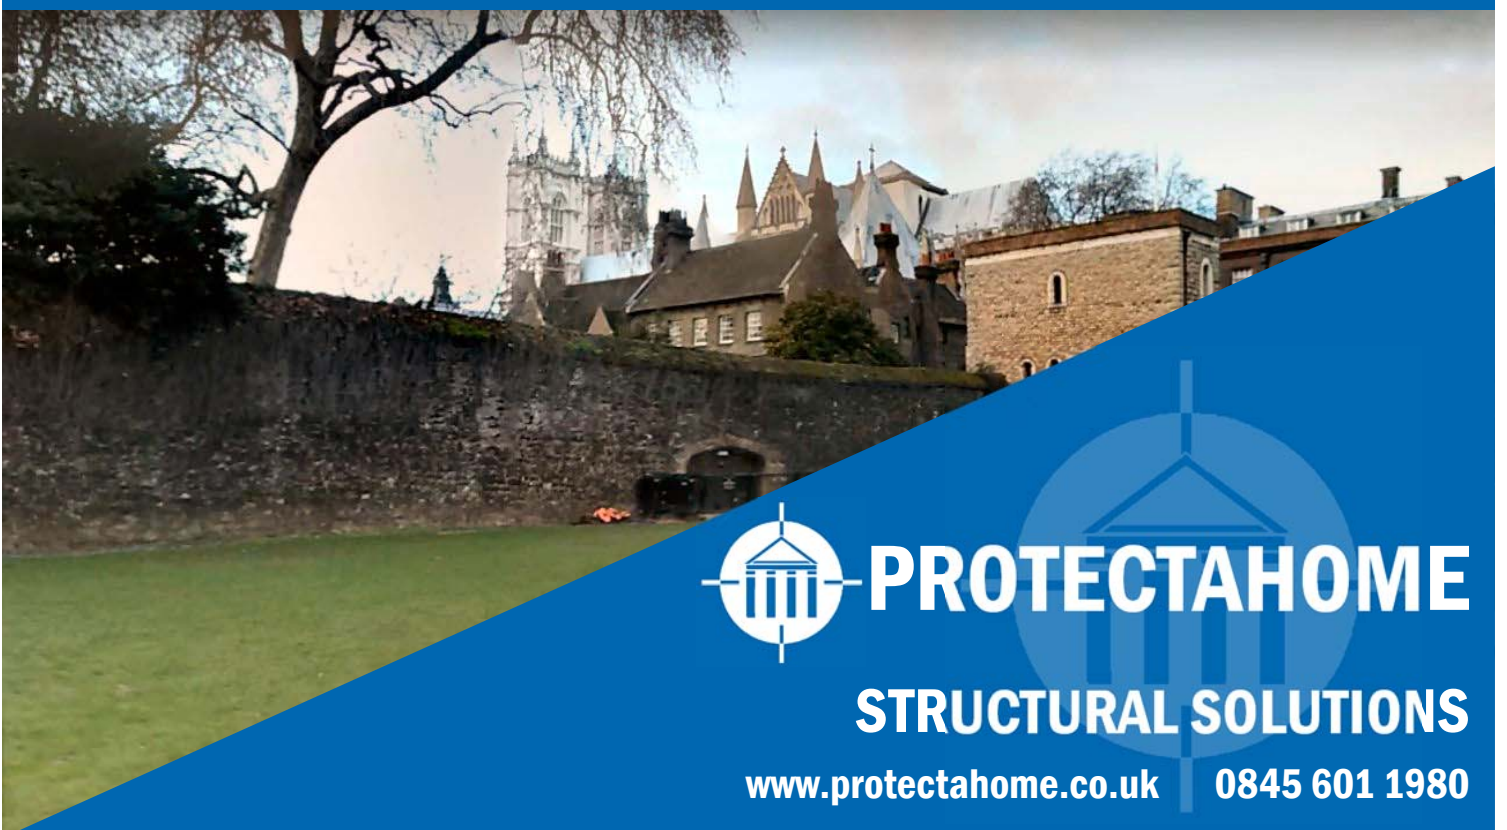
Westminster Abbey - The Problem

The rubble filled stone wall, which measures approximately 30m in length and up to 7m in height, is believed to date back to medieval times and had developed several large cracks which required specialist repair.

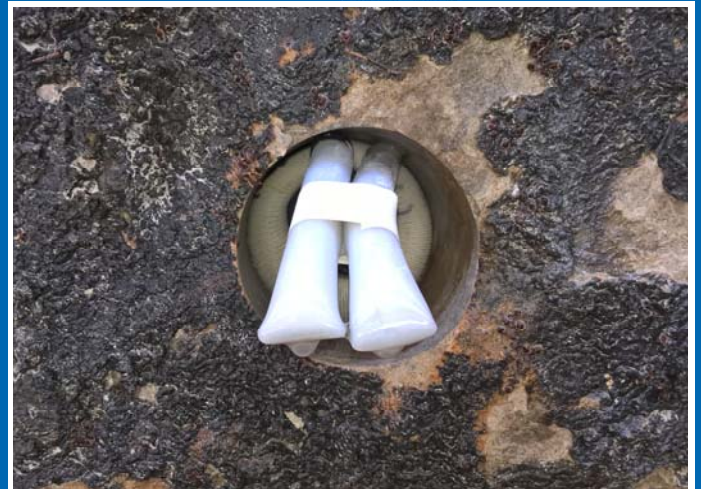
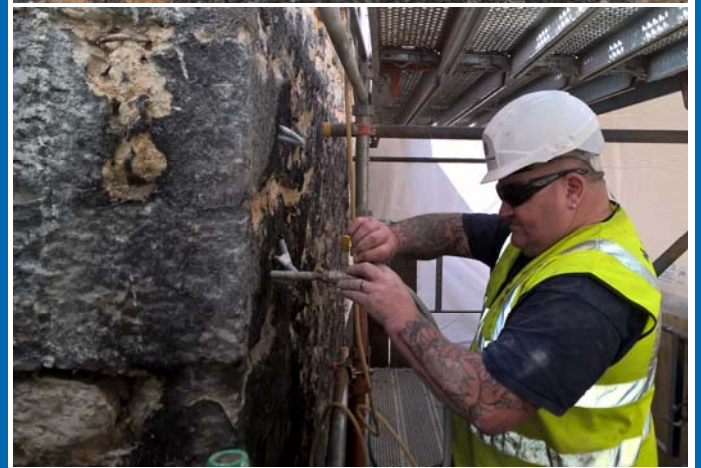
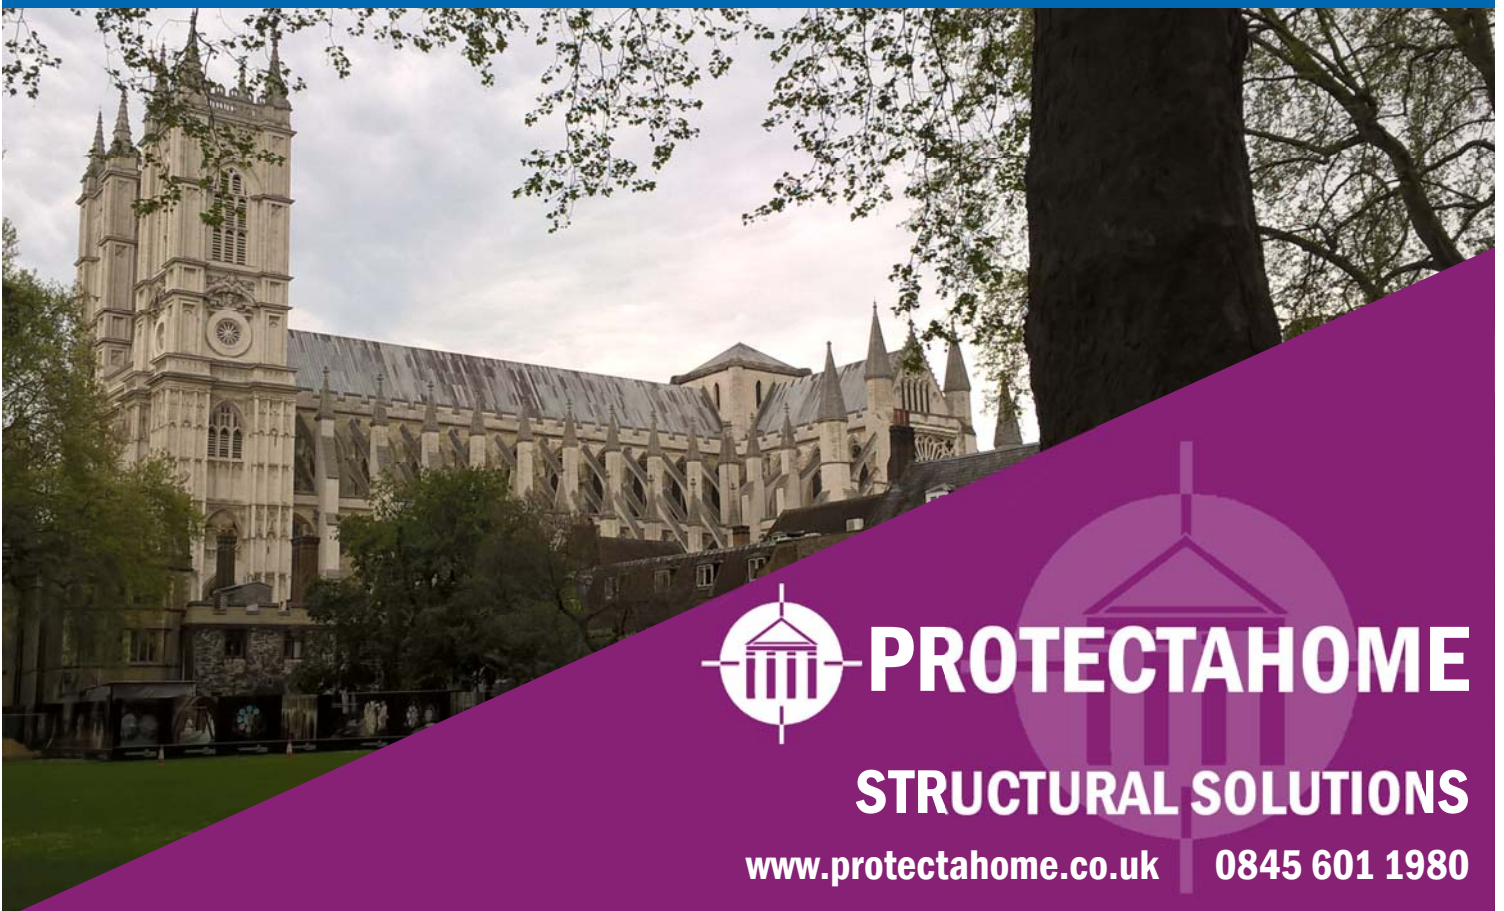
The 65mm 4.5m trial drilling revealed a very loose infill within the wall and determined that a mining barrel would need to be used to prevent the drill holes collapsing and refilling before the anchors could be installed. The anchors would be installed through the mining barrel, before the barrel was removed leaving the anchor in-situ.

Once in-situ, the sock anchors were then inflated with specialist grout to fill the voids within the wall to tie the cracked sections together and consolidate the existing wall structure.

Working in conjunction with the project engineer, Protectahome devised a repair scheme incorporating the use of specialist sock anchors.

In total, 5 No. 4.5m long anchors were installed to strategic locations along the wall.
