# Crack Stitching & Consolidation Anchoring Astley Castle, Warwickshire

Client: The Landmark Trust

## Case Study No: 60

RIBA Stirling Prize  
winning £2.5m  
restoration of this  
12th century Grade II  
listed manor house  
in Warwickshire.

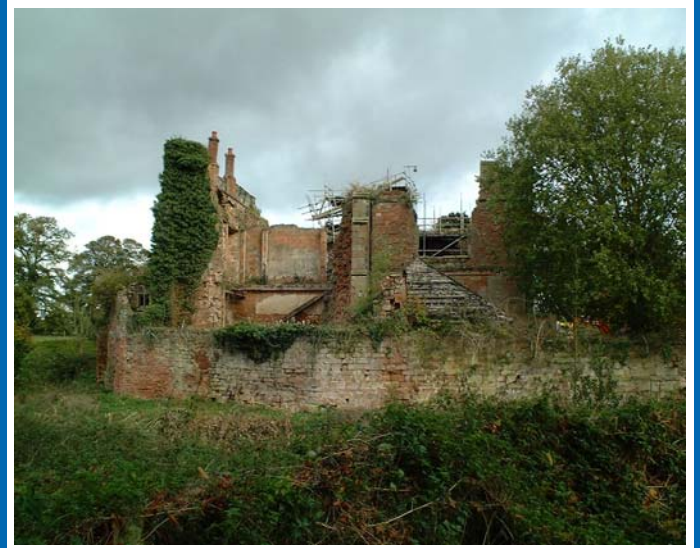
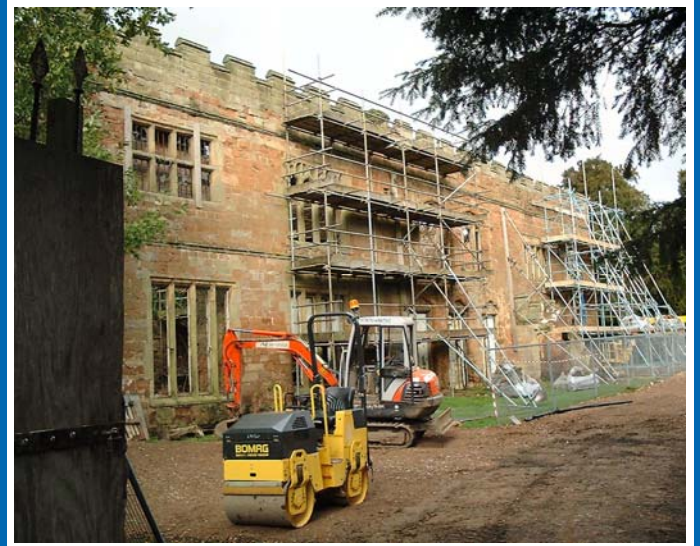
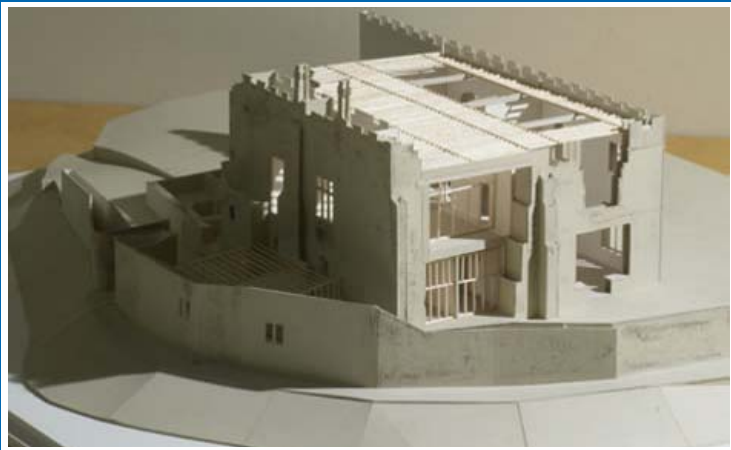
Devastated by fire in 1978, Astley Castle became the subject of an ambitious restoration project spanning three years and costing over £2.5million.
