PROTECTAHOME LTD STRUCTURAL SOLUTIONS

CRACK STITCHING & CONSOLIDATION, PLYMOUTH ROAD, PENARTH

Case Study: 249

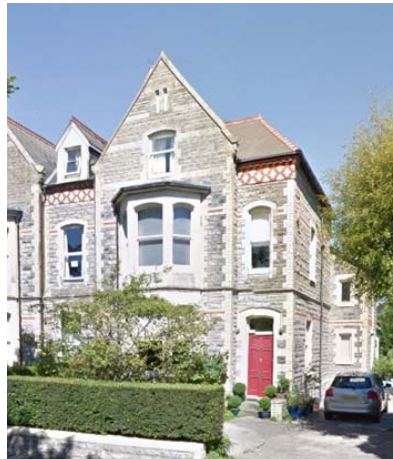
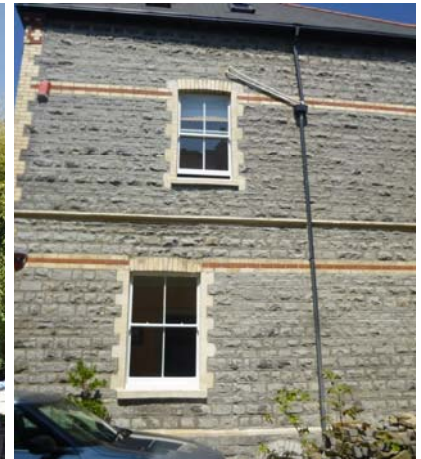
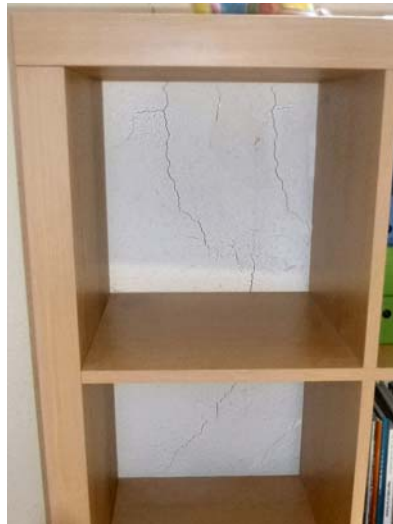
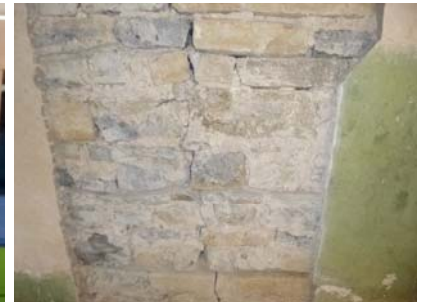
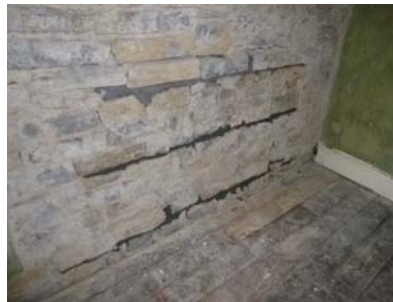
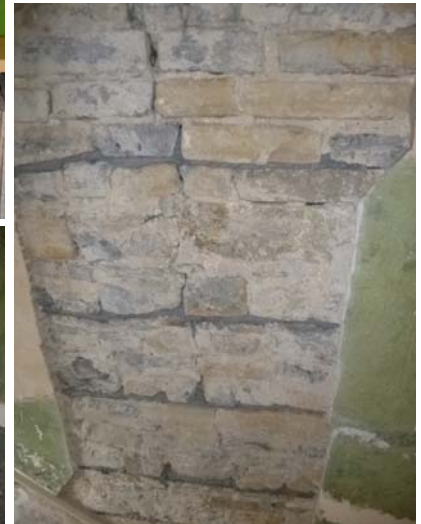
Protectahome were asked to inspect this three storey, semi-detached stone property in South Wales. The property is over 100 years old, constructed from Blue Lias Limestone and was suffering from cracking and a lack of consolidation on the right hand side elevation wall.

This was the result of a loss of bond between the inner and outer skins stonework and settlement of the rubble fill.

To permanently stitch cracks, 8 No: individual 1m long stainless steel HeliBars were bonded into channelled-out mortar beds, using HeliBond cementitious grout. Following installation of the HeliBars, a stainless steel mesh was applied to the problem area before replastering took place, leaving no sign of the internal cracking.

CemTies were installed across the whole wall, in a staggered matrix pattern, to provide consolidation and secure the inner and outer leaves of the rubble filled wall. CemTies were selected as they provide a highly cost effective, fully grouted tying system and have great tensile strength.

All external drill holes were repointed using matching mortar, leaving very little or no sign of the structural repair work undertaken.
