Case Study 049N:

FLOOD MITIGATION - PIXTON HOUSE, WORCESTERSHIRE

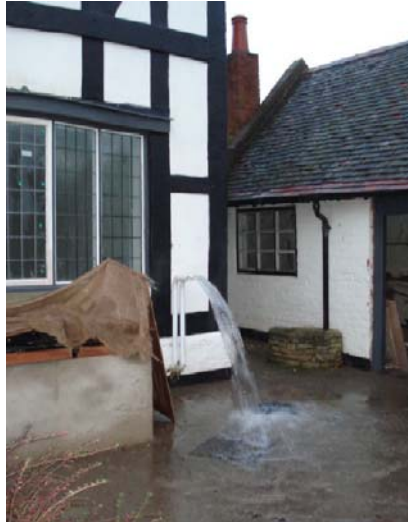
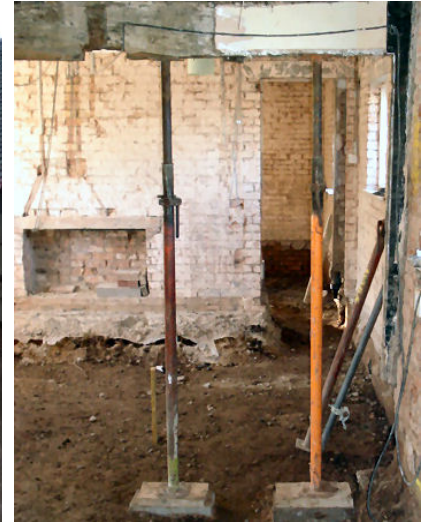
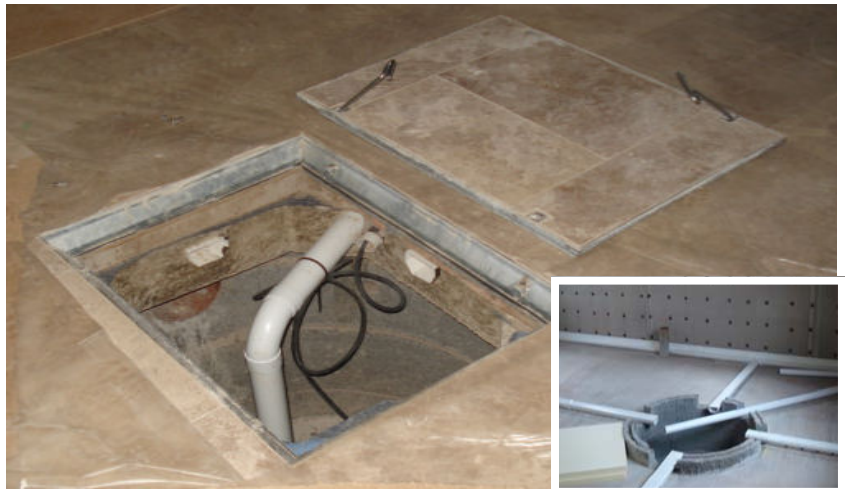
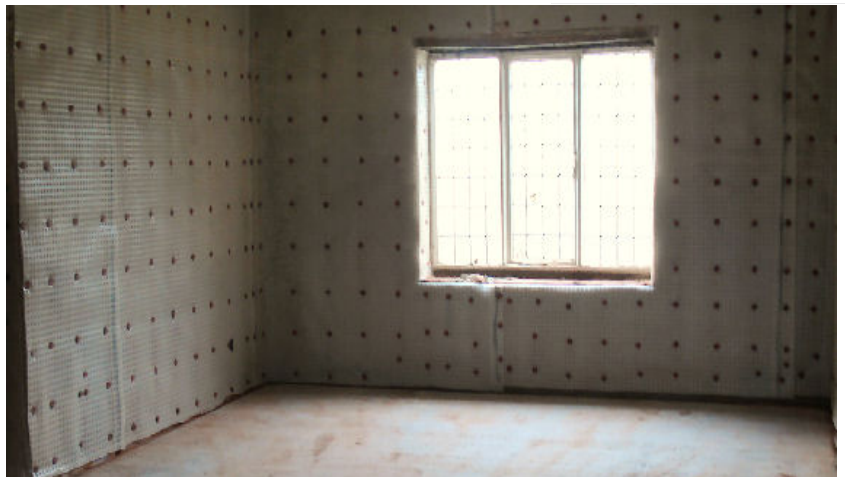
A comprehensive Waterproofing scheme was designed and installed by Protectahome which incorporated the use of both Drained Protection Waterproofing and Cellar Tanking.

The Combined Waterproofing system extends throughout the Ground Floor and Cellar including for all walls and floors.

The Waterproofing utilises 8mm and 20mm Cavity Drain Membranes from Newton Membranes, Epoxy Resin Tanking, Basedrain Perimeter Drainage Channels and a series of Sump Chambers. Into the Sump Chambers, high capacity Newton NP750 Sump Pumps were installed. All pumps work in parallel to offer maximum pumping capacity across the whole foot print of the Ground Floor and the Cellar.

A range of measures were also employed to improve the property's Flood Resilience and Flood Resistance. These included for the replacement of timber floors in solid construction, as well as the installation of Demountable Flood Protection for openings.
