Case Study 002N:

BASEMENT WATERPROOFING - ST MARY STREET, MONMOUTH

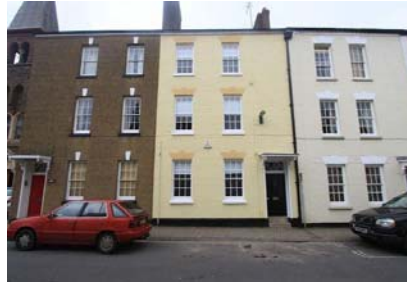
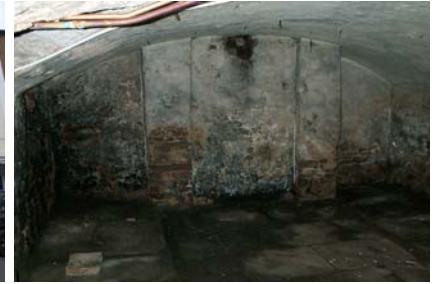
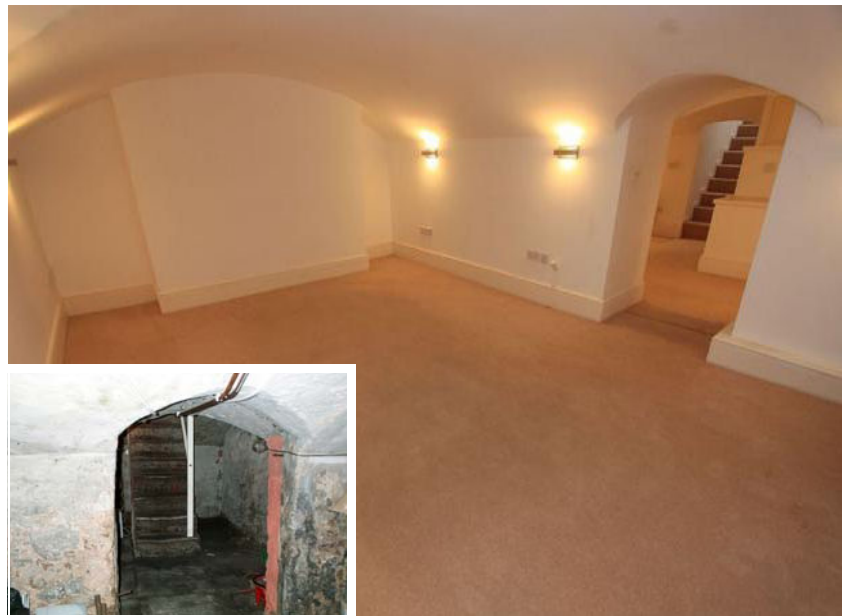
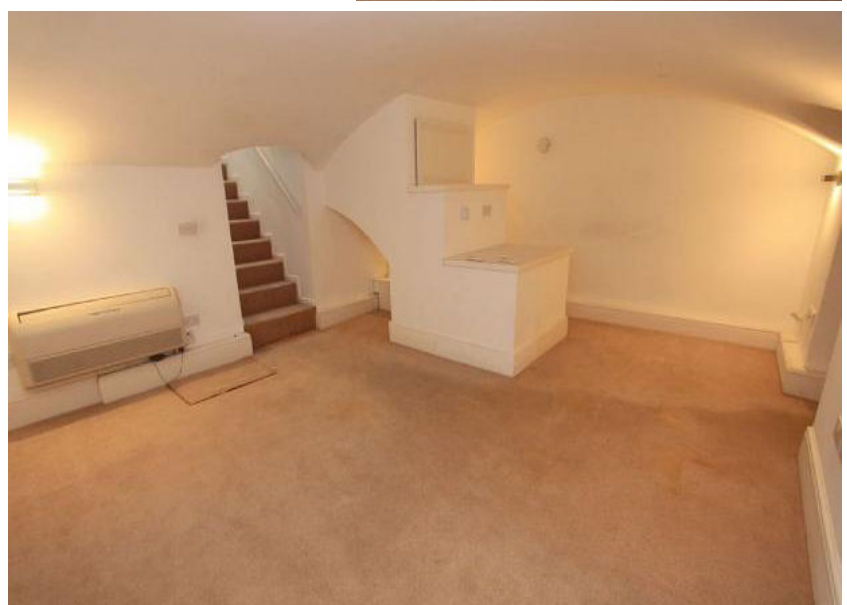
An existing vaulted Damp Cellar under a Listed Building in the Historic town of Monmouth. The Cellar had a known history of ground water flooding and had rudimentary drainage channels already built into the original flagstone floors.

Protectahome designed and installed a Waterproofing System that included Basedrain Perimeter Drainage Channel connected to multiple Sump Chambers. In each Sump Chamber there are two Newton NP150 Automatic Sump Pumps with High Water Alarms and Battery Back Ups.

Newton Membranes 508 Cavity Drain Membrane was applied to walls and floors. Newton Membranes 508 Mesh Membrane (with a mesh welded to the surface) was fixed over the vaulted ceilings ready to accept the application of render coats.

Our ingenious design included the use of combined wall finishes enabling services to be hidden behind metal framed stud walls. These walls were constructed at low level, between the floor and the springing points of the vaults.
