Case Study 176:

DRY ROT ERADICATION - CAPEL ABERFAN, ABERFAN

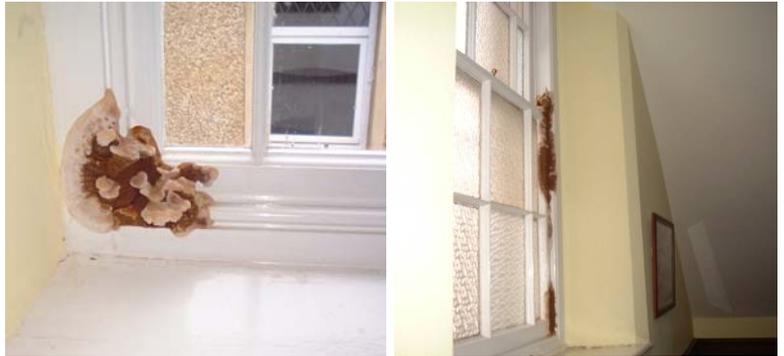
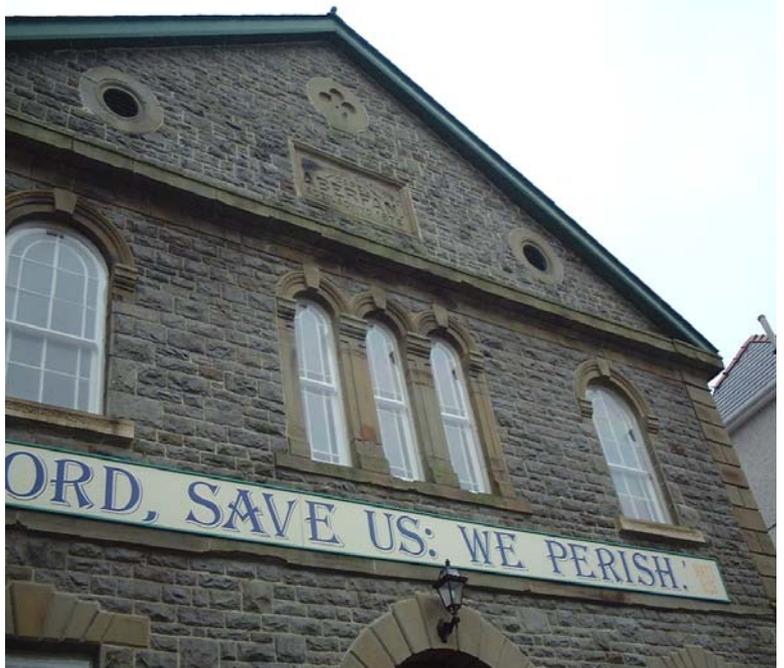
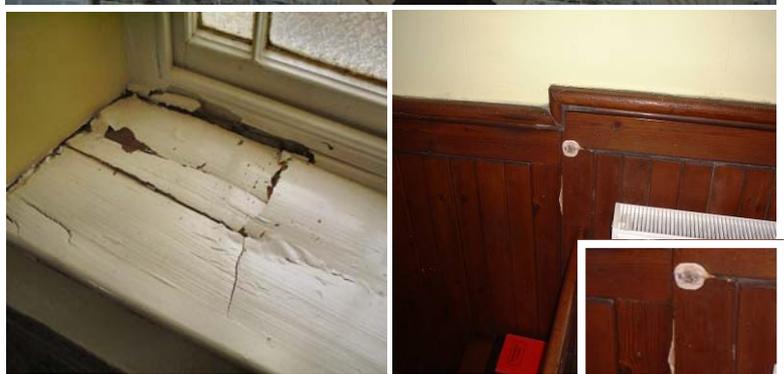
After removal of the wall plaster it was found that severe decay had taken place to concealed timbers such as window lintels and roof truss ends. The large arched stain glass windows, first floor balcony structure and wainscot panelling were also badly affected.

Protectahome's directly employed Operatives performed the opening up works and all defective timbers were removed and replaced with new treated timbers. Extensive Dry Rot Treatment was also completed. The property has now been fully restored and stands in it's former glory.
