# Podium Deck Waterproofing Residential Care Home Swansea

## Case Study No: 203

- Podium Deck Waterproofing
- Elastomeric Liquid System
- Full Design & Installation

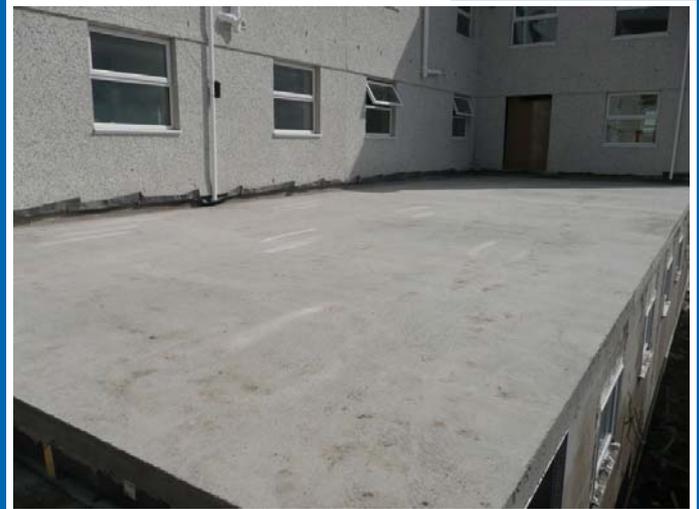
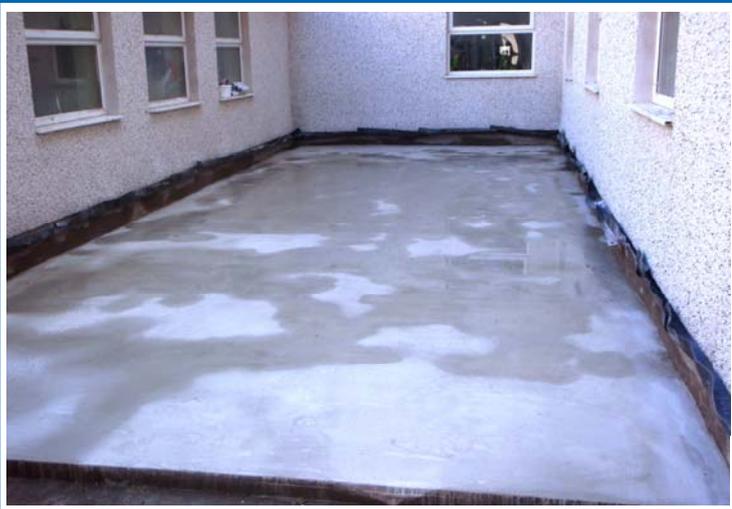
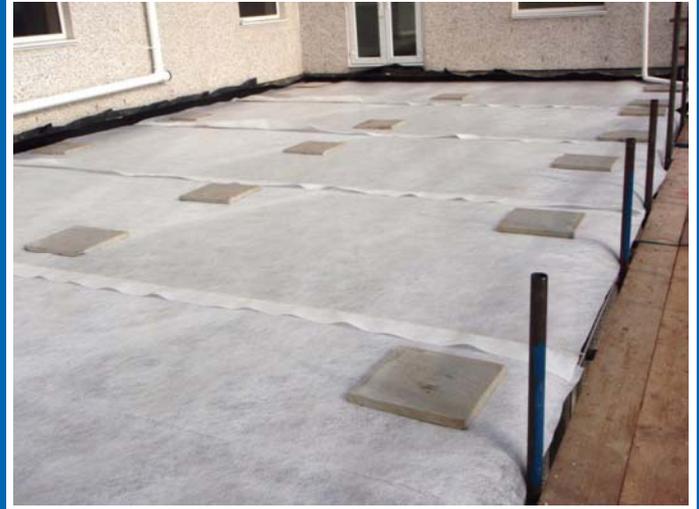
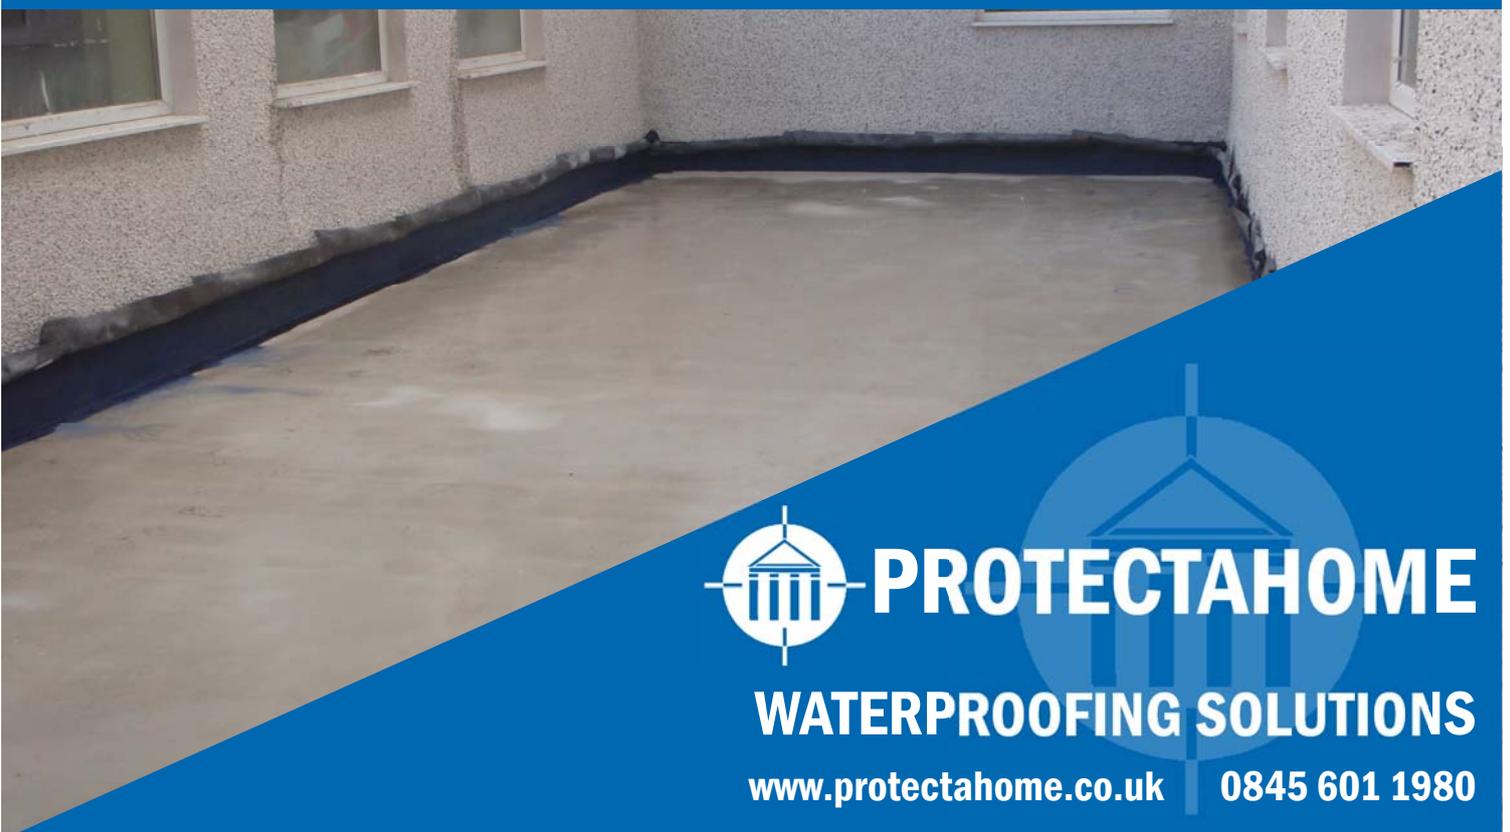
During the construction of a new, purpose built, residential care home two podium decks were constructed that required waterproofing.

The waterproofing had to be designed and installed to a high standard in order to protect the new, state of the art residents gymnasium, treatment and therapy rooms constructed directly below.

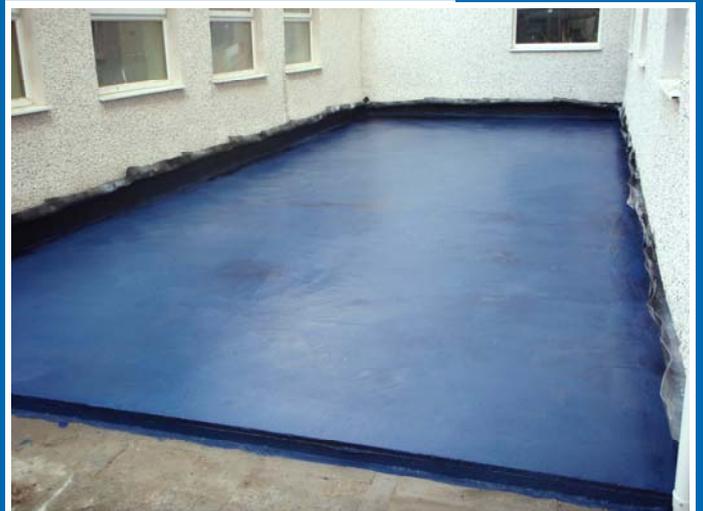
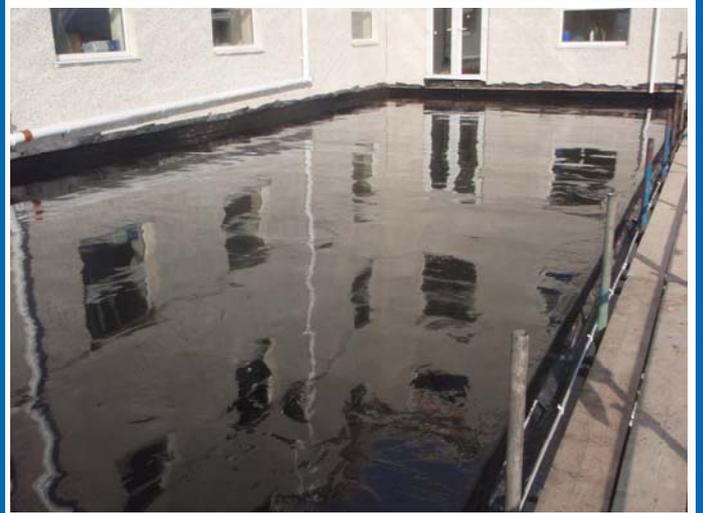
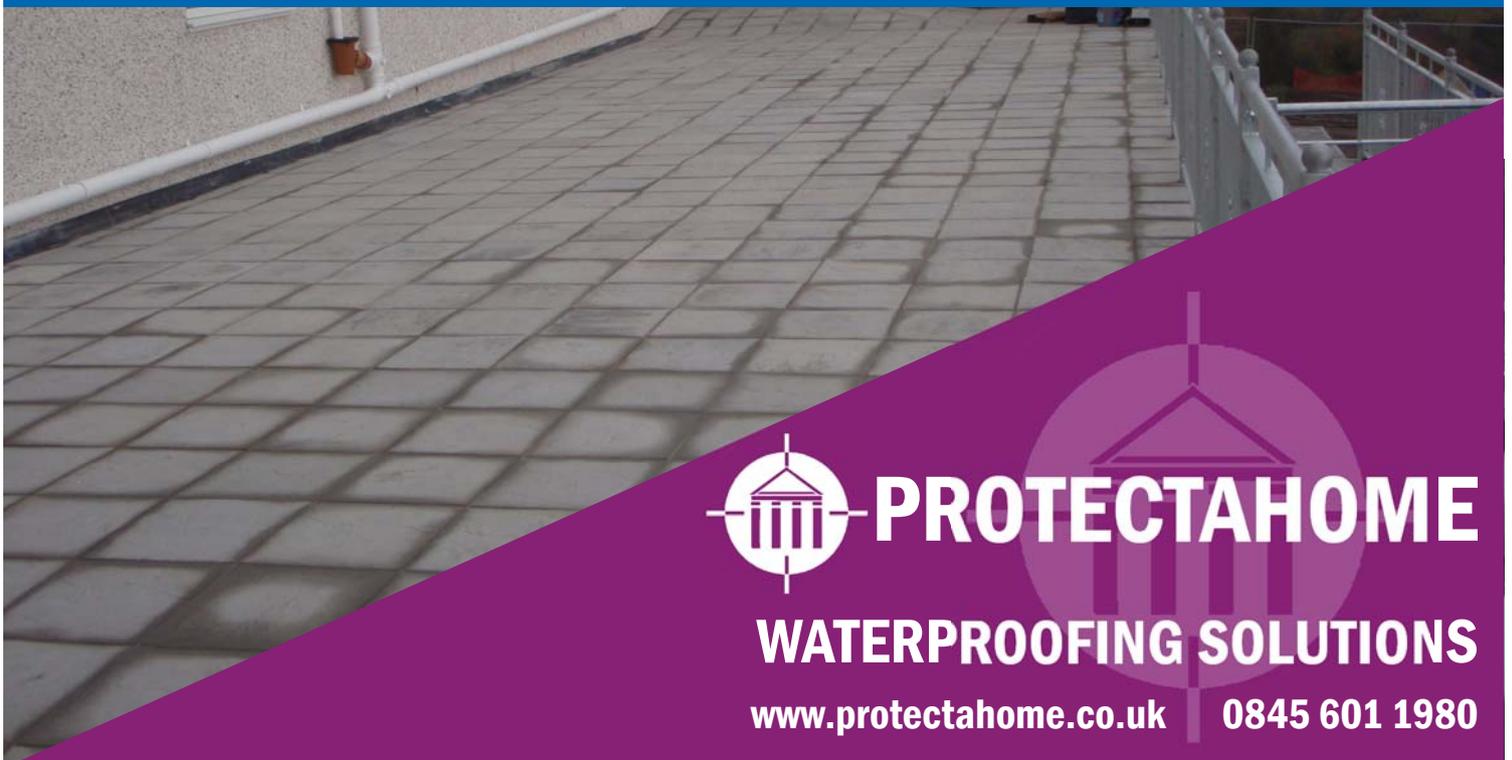
An elastomeric liquid roofing and waterproofing system was selected by Protectahome's team of specialist surveyors to provide a highly flexible, seamless membrane over the podium deck, upstands and details.

After paying meticulous attention to the preparatory work, including setting and checking appropriate falls compliant with BS 6229, a liquid rubber primer was carefully applied by Protectahome's own trained and experienced technicians.

Once curing had taken place, a base coat of Elastomeric two part Polyurethane liquid waterproofing was applied to all surfaces, with thickening agents included on vertical surfaces.

Checking film thickness was sufficient, our technicians then installed reinforcing tape into the base coat of the waterproofing at all 90 degree corners and angles – traditional areas of weakness and potential movement in deck waterproofing systems.

Closely monitoring weather conditions as the waterproofing system selected cures by reaction with relative humidity and temperature, a second top coat of Polyurethane waterproofing was applied.

Allowing for full curing of the waterproofing, a protective drainage layer was installed which comprised of a preformed, polyethylene, double cusped drainage sheet with a geotextile filter welded to the surface.
