Lateral Restraint Plymouth Road, Penarth, South Wales

Case Study No: 248

To arrest further movement and bowing of the right hand elevation of this Blue Lias Limestone property in Penarth.

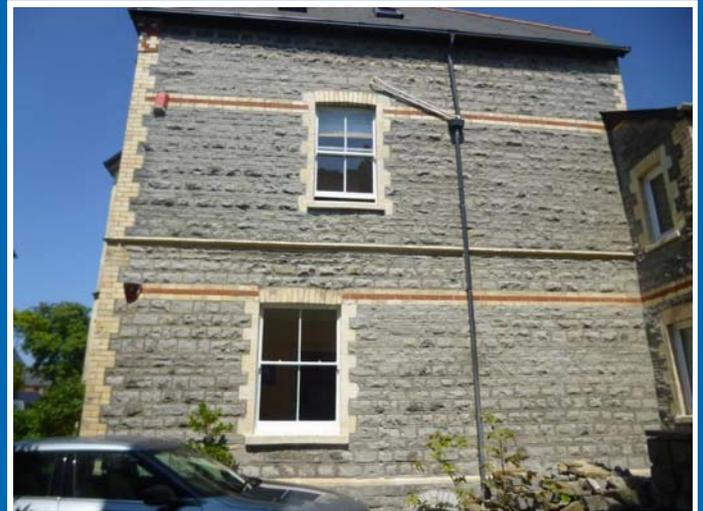
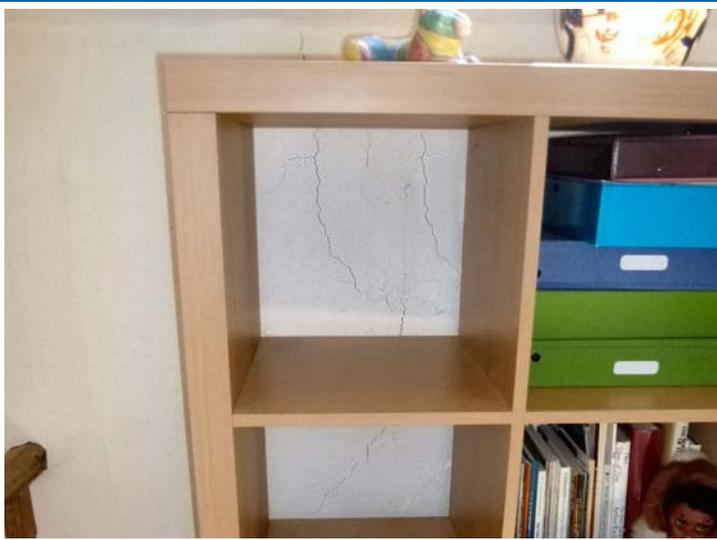
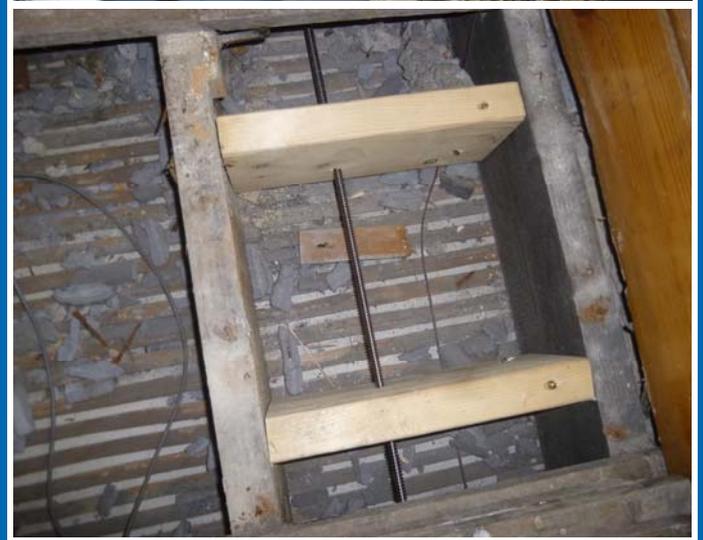
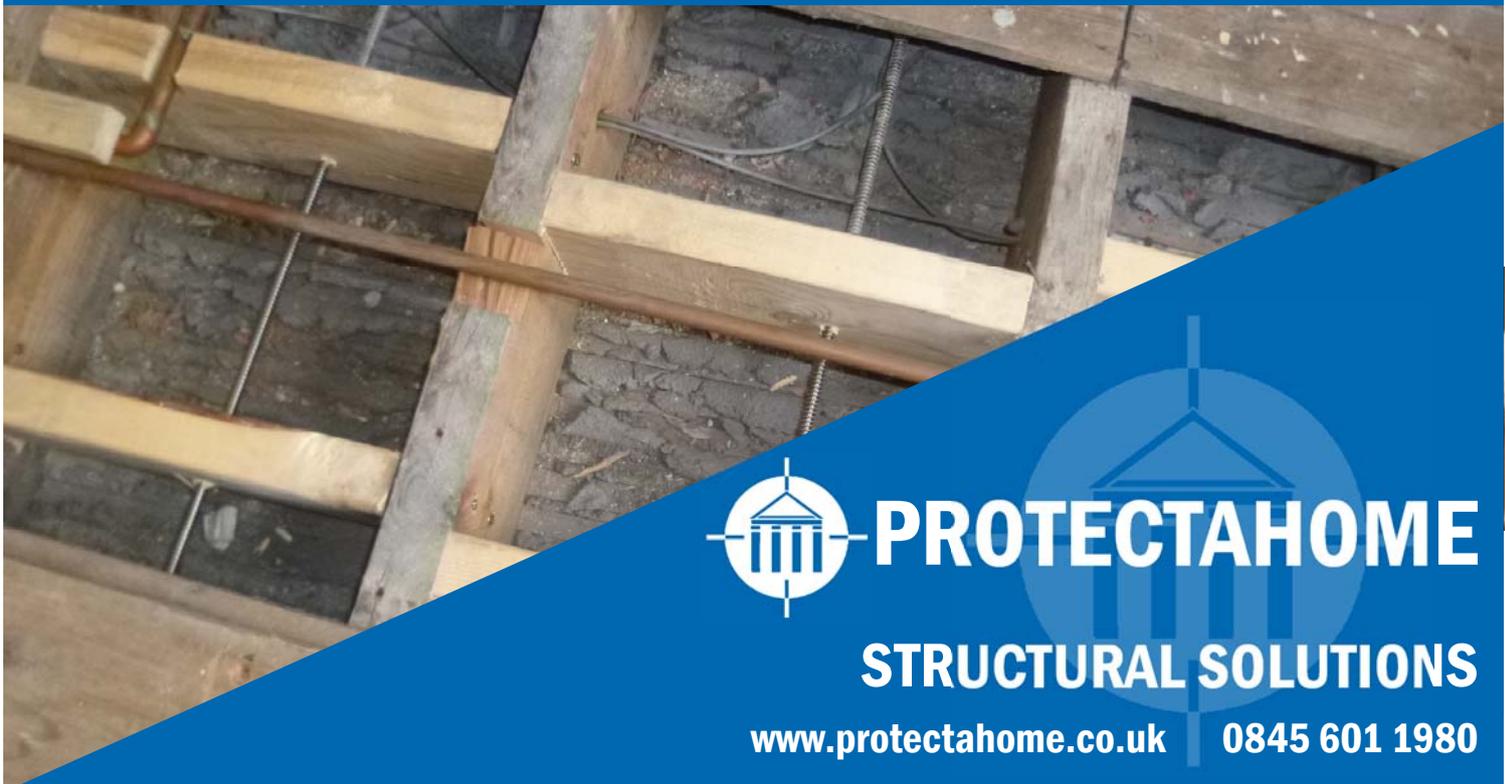
Plymouth Road, Penarth - The Problem

Protectahome were asked to inspect this three storey, semi-detached stone property in South Wales. The property is over 100 years old, constructed from Blue Lias Limestone and was suffering from bowing of the right hand side elevation wall.

This was the result of a loss of bond between the inner and outer skins stonework and settlement of the rubble fill coupled with inadequate Lateral Restraint of the wall.

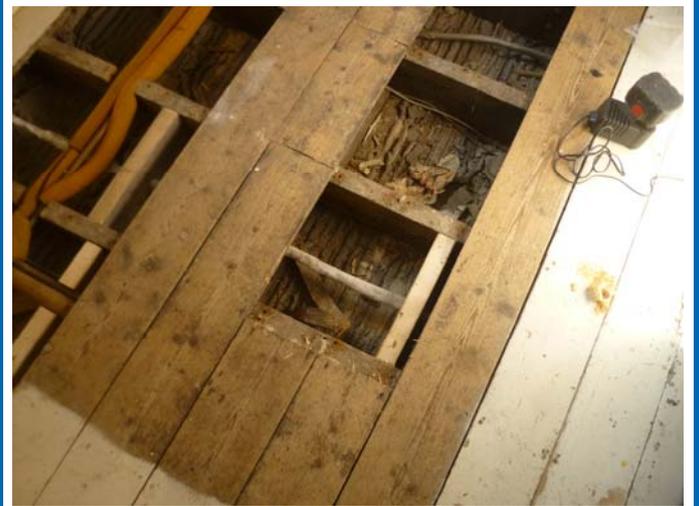
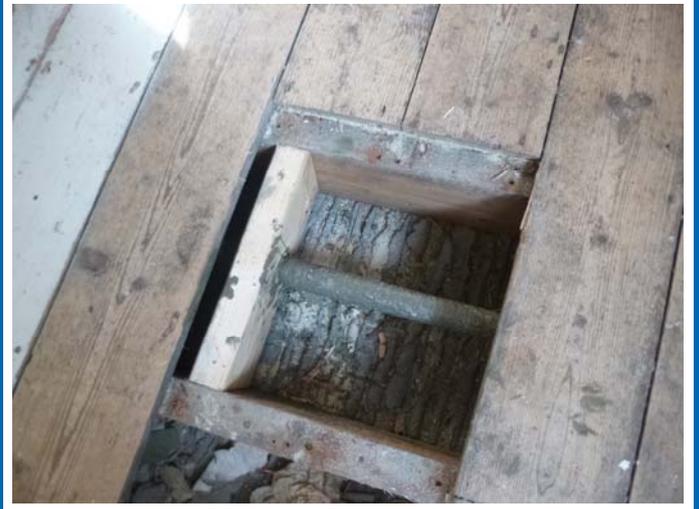
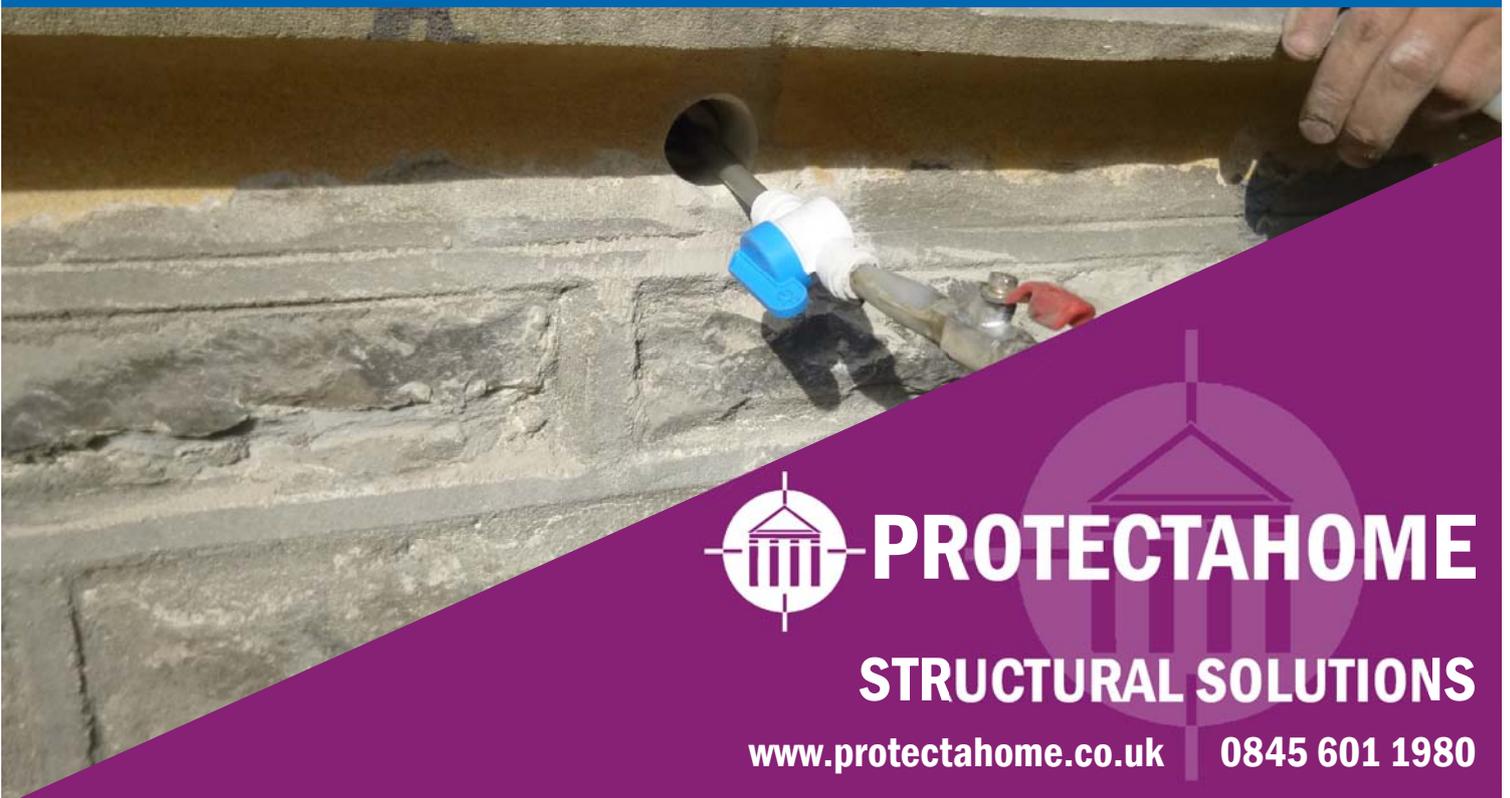
Plymouth Road, Penarth - The Solution

Protectahome's surveyor completed a detailed inspection of the problem areas and concluded that an economical, non-disruptive means was required to stabilise the 500mm thick wall and to fully secure it to the main property.

A repair scheme was devised that utilised Helifix SockFix Anchors and HD BowTies to restore lateral restraint to the wall.

HD BowTies were installed at the first and second floor levels. Clearance holes were drilled through the wall and BowTies were then inserted and driven through the first two parallel floor joists before the outer ends were resin bonded into the stone work.

Following the core drilling of clearance holes, 3m long SockFix anchors were inserted through the wall and the floor joists around the landing areas. Once the SockFix anchors had been inflated with grout, they expanded between the joists to secure the wall to the floor structure.

Original cores were kept and later replaced following the installation, leaving very little or no sign of the structural repair work undertaken.
