Remedial Damp Proofing

Churchill Road, Bordesley Green, Birmingham

Case Study No: 276

The Project:
To provide a guaranteed solution to rising dampness at ground floor level within this terraced West Midlands property.

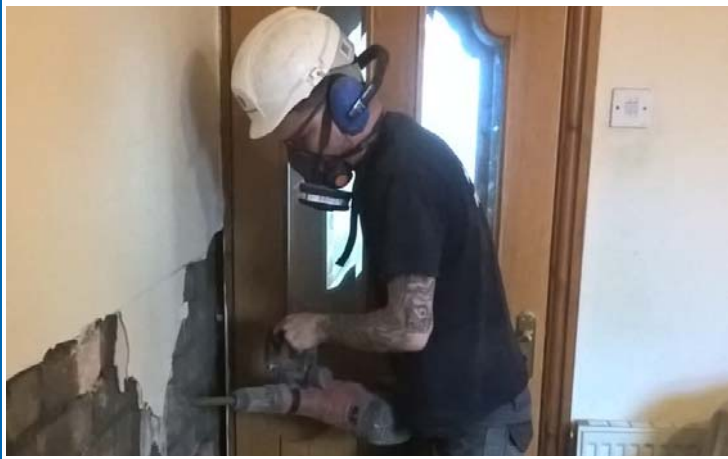
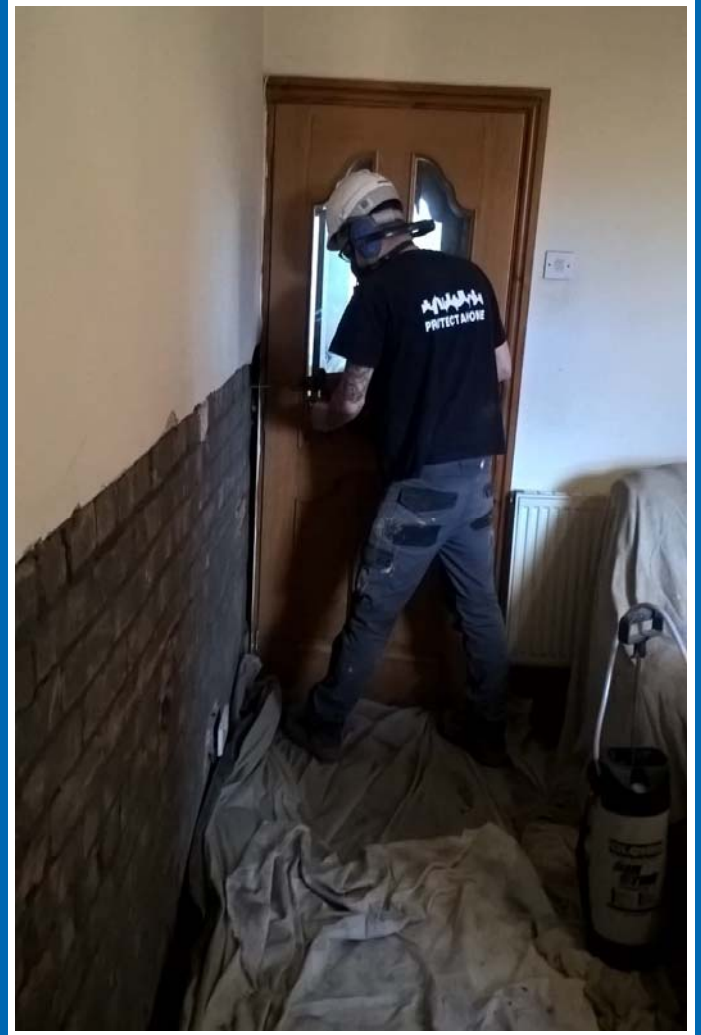
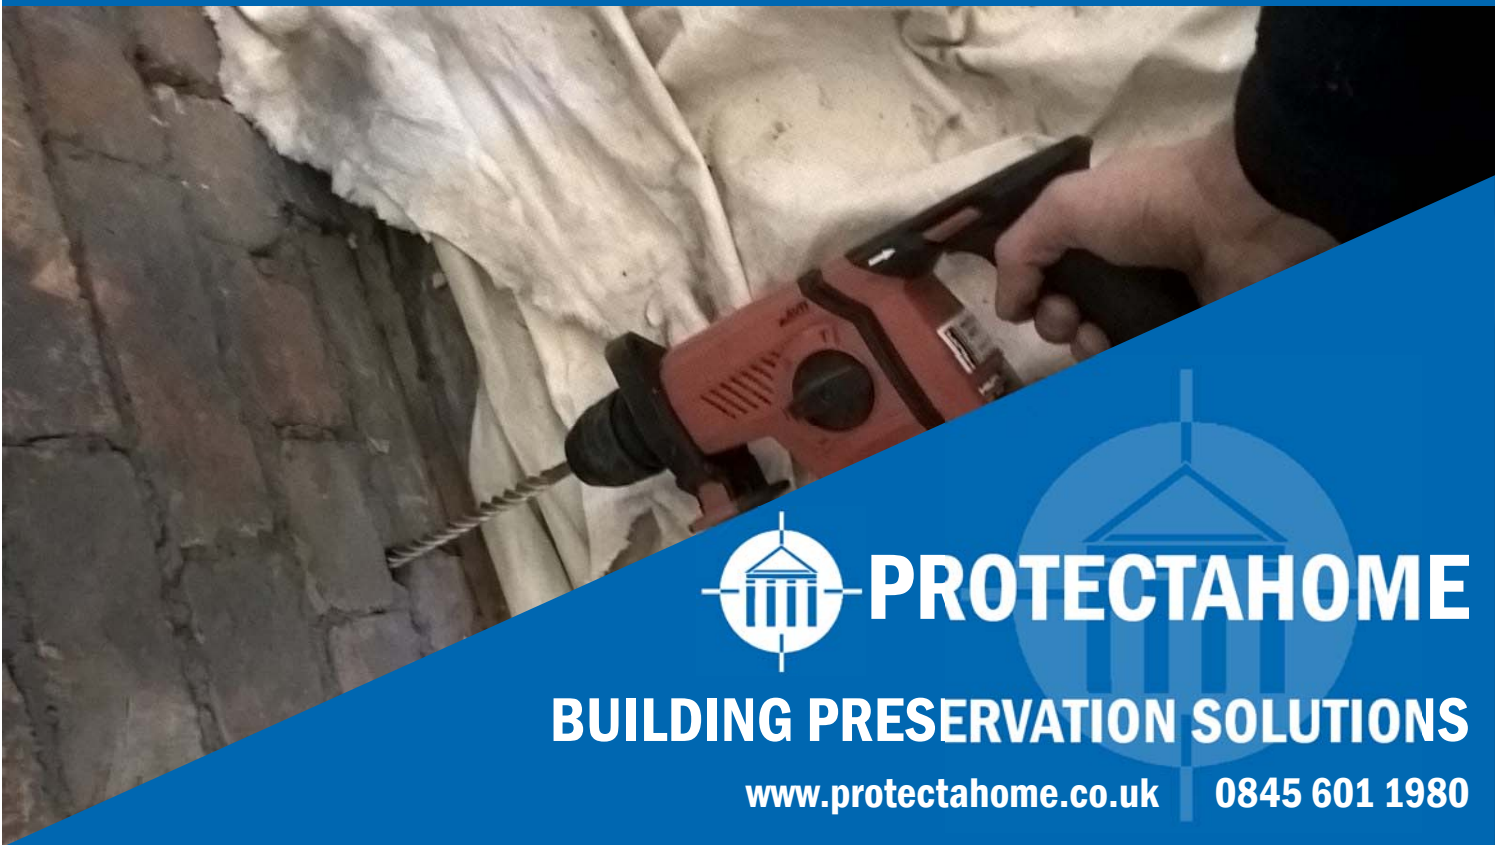
Churchill Road, Birmingham - The Problem

This 2 bedroom, brick built terraced property of approximately 80 years of age, was suffering from rising damp to the right hand elevation at ground floor level.

After a detailed inspection of the property and the possible causes of the apparent dampness, a lack of physical damp proof membrane was identified and a scheme of remedial damp proofing was specified to prevent further rising dampness via capillary movement.
