# Dry Rot Eradication Domestic Property Rumney, Cardiff

## Case Study No: 285

To investigate and later eradicate an attack of Dry Rot (*Serpula lacrymans*) to this domestic property in Rumney, Cardiff.

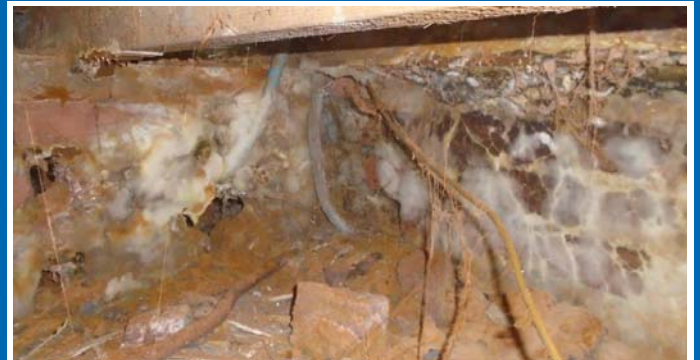
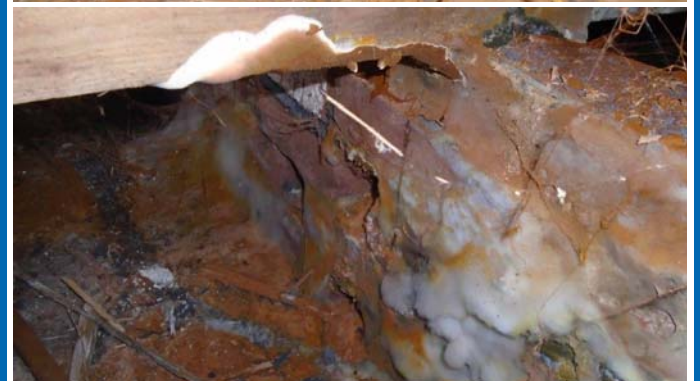
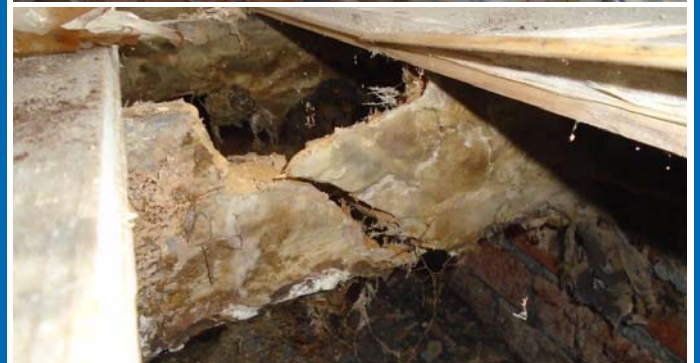
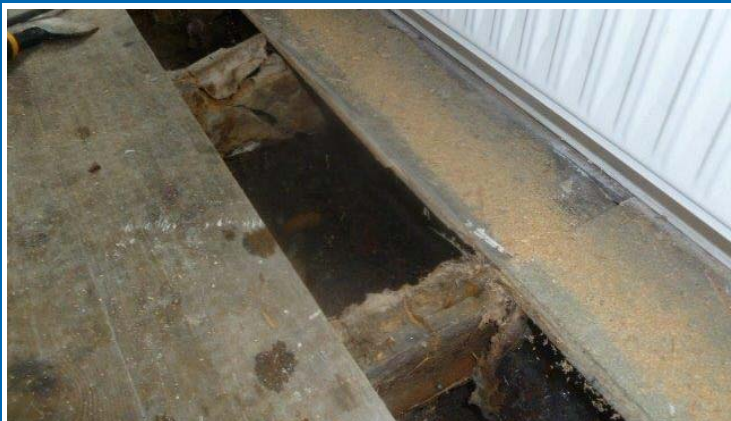
Protectahome's CSRT qualified surveyor attended the property and noted evidence of a substantial, and well established, dry rot outbreak affecting several floor joists and wall plates.

A further destructive investigation was undertaken to ascertain the extent of the outbreak and to determine that the cause of the attack was a combination of poor sub-floor ventilation combined with untreated and un-isolated timbers bearing into the damp external walls below DPC level.

It was also noted that the external walls were susceptible to increased dampness levels due to rainwater not being directed away from the base of the property.
