# Commercial Waterproofing Aston Hall Hotel, Near Sheffield

## Case Study No: 295

- New Build Construction
- Type C (Drained) Protection
- Full Design & Installation
- Long Term Guarantee

The construction of a detached, part retaining, new build function and events building for the Best Western, Aston Hall Hotel, Sheffield.

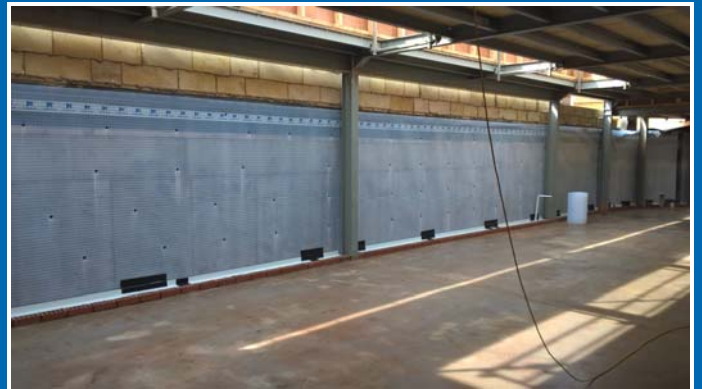
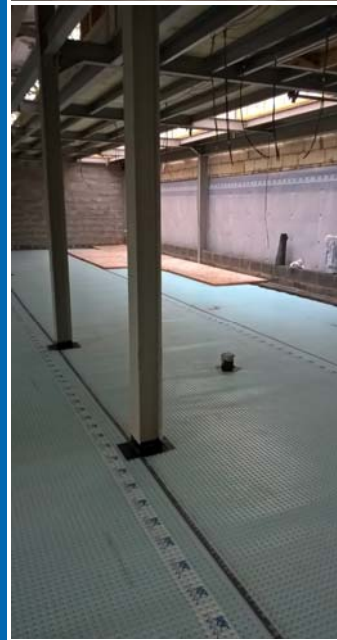
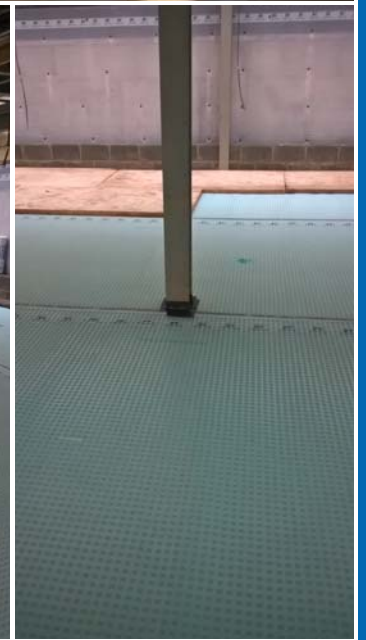
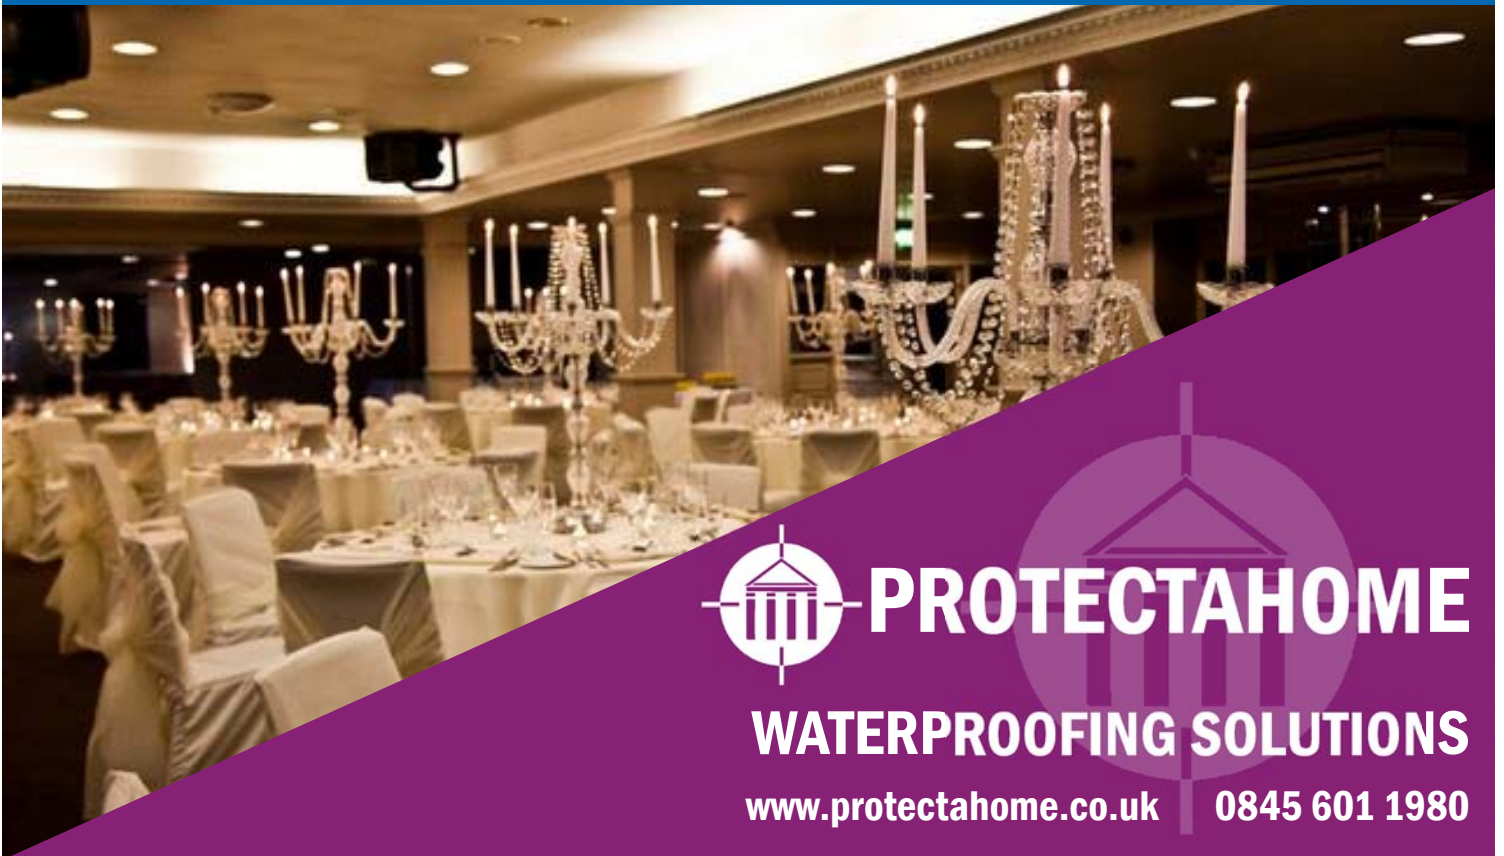
The Type C system took the form of 8mm stud Cavity Drain Membranes installed to the earth retaining wall sections and across the floor of the part reinforced concrete, part blockwork structure.

At the wall/floor junction, a specially designed perimeter drainage channel was laid on top of the floor slab to collect and redirect any free water that penetrated the structure behind the studded membranes.

Service/maintenance ports were fitted to the perimeter channel at strategic locations to allow for future inspection and maintaining of the system.
