PROTECTAHOME LTD STRUCTURAL SOLUTIONS

LATERAL RESTRAINT, PLYMOUTH ROAD, PENARTH

Case Study: 243a

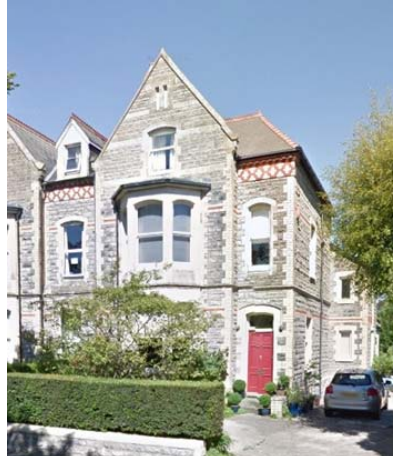
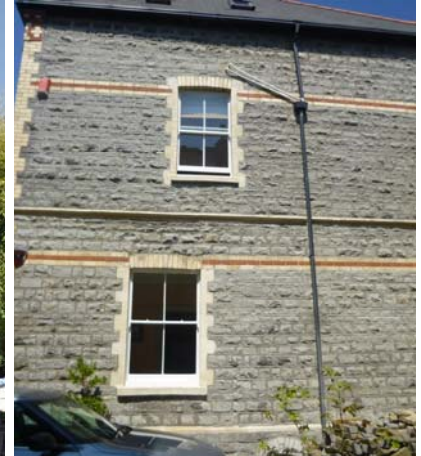
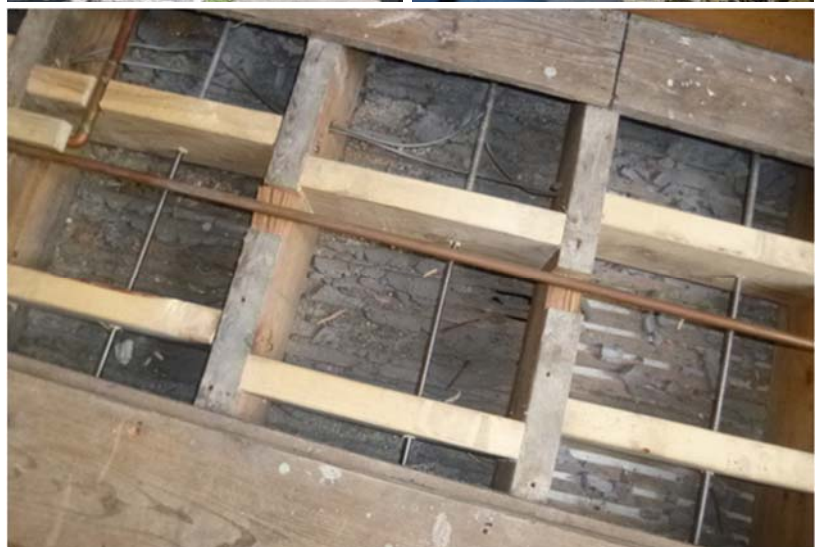
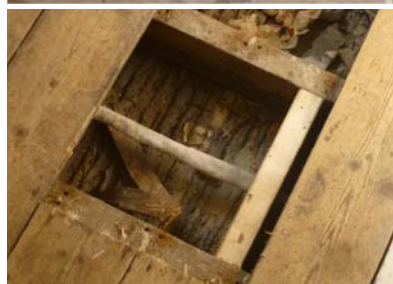
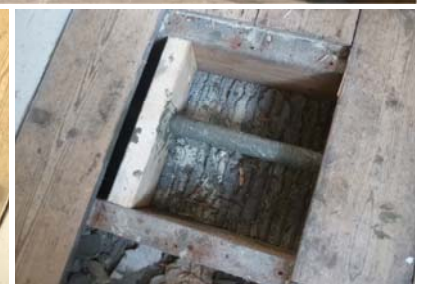
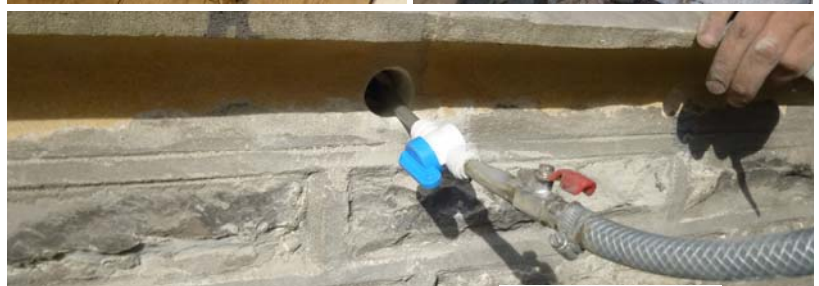
Protectahome were asked to inspect this three storey, semi-detached stone property in South Wales. The property is over 100 years old, constructed from Blue Lias Limestone and was suffering from a bowing right hand side elevation wall.

This was the result of a loss of bond between the inner and outer skins stonework and settlement of the rubble fill coupled with inadequate lateral restraint of the wall.

A repair scheme was devised that utilised Helifix SockFix Anchors and HD BowTies to restore lateral restraint to the wall.

HD BowTies were installed at the first and second floor levels. Clearance holes were drilled through the wall and BowTies were then inserted and driven through the first two parallel floor joists before the outer ends were resin bonded into the stone work.

Following the core drilling of clearance holes, 3m long SockFix anchors were inserted through the wall and the floor joists around the landing areas. Once the SockFix anchors had been inflated with grout, they expanded between the joists to secure the wall to the floor structure.

Original cores were kept and later replaced following the installation, leaving very little or no sign of the structural repair work undertaken.
